# Guardian Home Inspection, Inc

## Property Inspection Report

12345 Main St. , Awesome Town , CA. 90000  
Inspection prepared for: Sample Inspection Report  
Real Estate Agent: Realtor Name -

Date of Inspection: 1/1/2025  
Inspector: Angel "Frank" Garcia

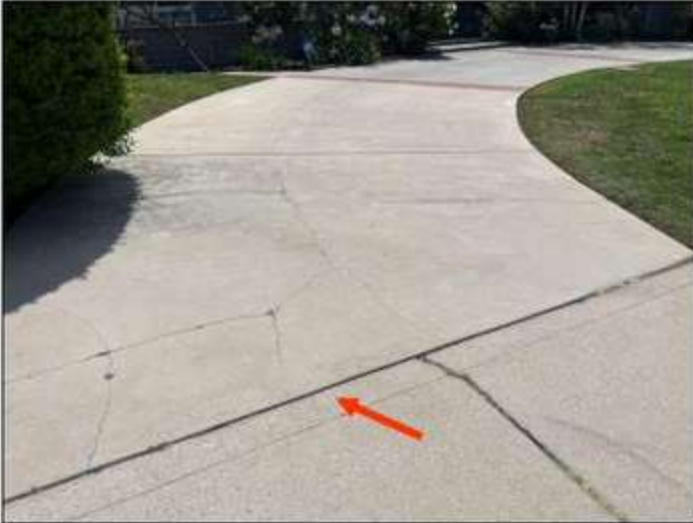
(trip hazard city) Driveway is settled/lifted at city sidewalk creating trip hazard \*(4).

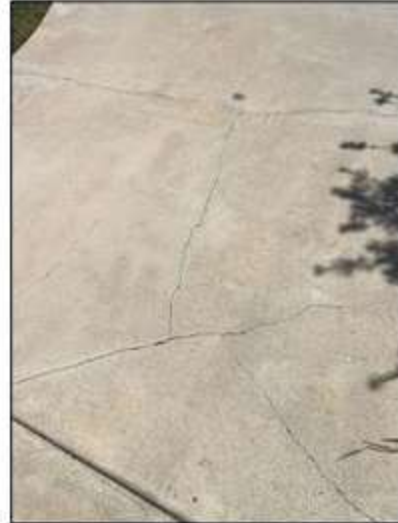
Driveway had common cracks \*, Appears serviceable.

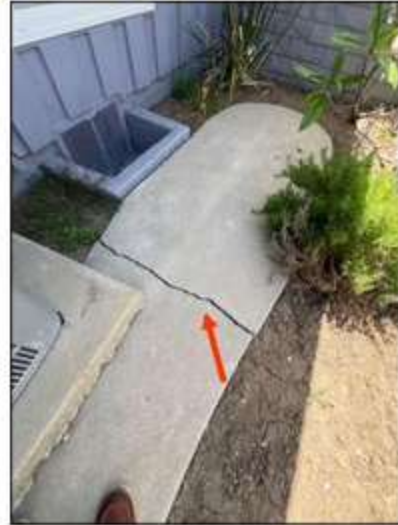
(step off trip front ) Concrete sidewalk has step off at joint(s) causing trip hazard located at front of property \*(4), recommend repair as a safety upgrade. Consult licensed contractor for further review and repair.

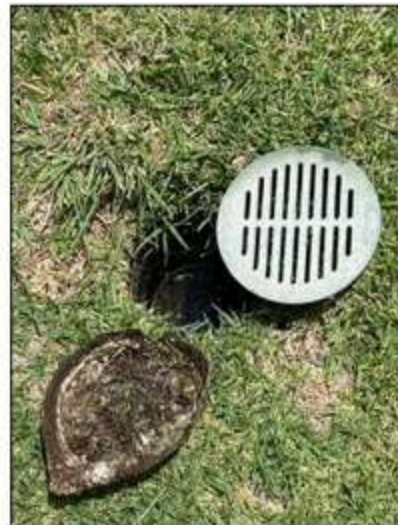
Rear lawn area surface drain is clogged (2), recommend repair.

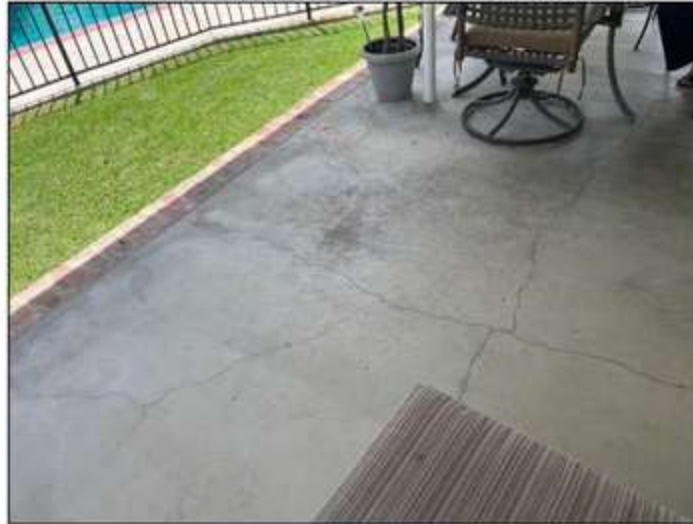
Patio (A) porch is concrete, patio has common cracks \*.

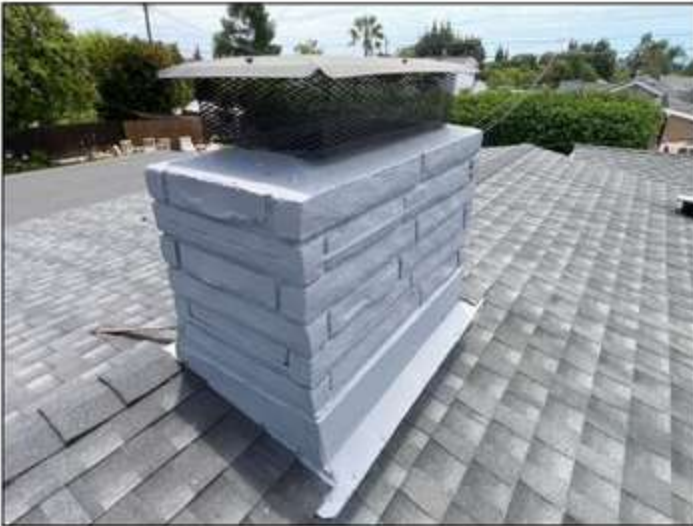
(crack crown) Chimney rain masonry cap/crown is cracked which will allow water to enter into inner chimney brick and mortar which prematurely age chimney deteriorating structure (2), recommend repair.

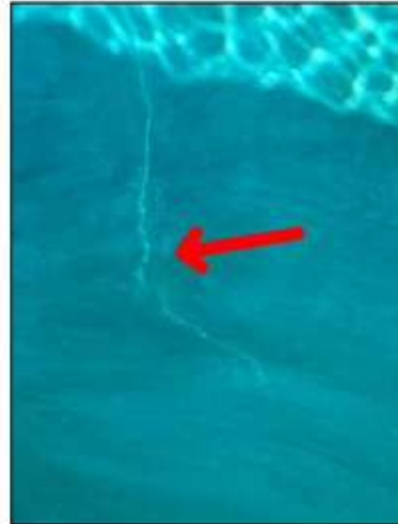
Pool body plaster has a visible crack/fracture in the middle section of the pool plaster, in addition a water hose placed inside the water suggests an active effort to compensate for water loss (2). The pool appears to be leaking, recommend further review repair by licensed pool contractor.

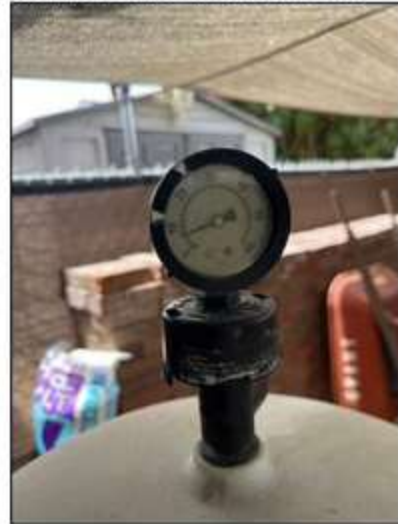
Diamtomaceous earth filter installed, appears serviceable. Interior of filter canister was not opened/inspected \*. Recommend having Pool contractor clean and service filter as a preventative maintenance measure or ask home owner when last time pool was serviced.

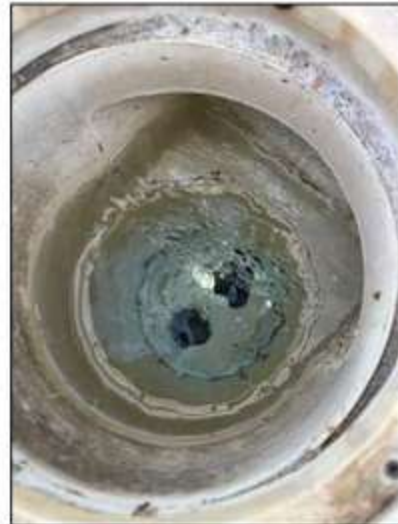
Skimmer located at deck near deep end, body of skimmer appears serviceable with no visible cracks.

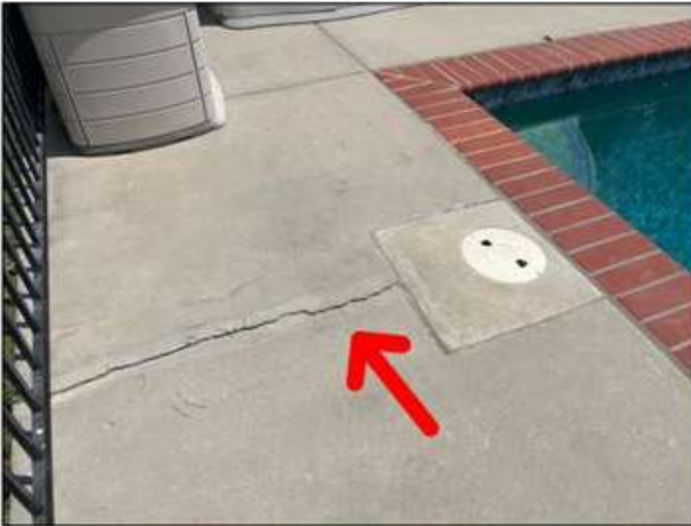
Pool deck has visible crack(s) at various areas (2), recommend further review and repair by licensed pool contractor to repair/replace pool concrete deck (2).

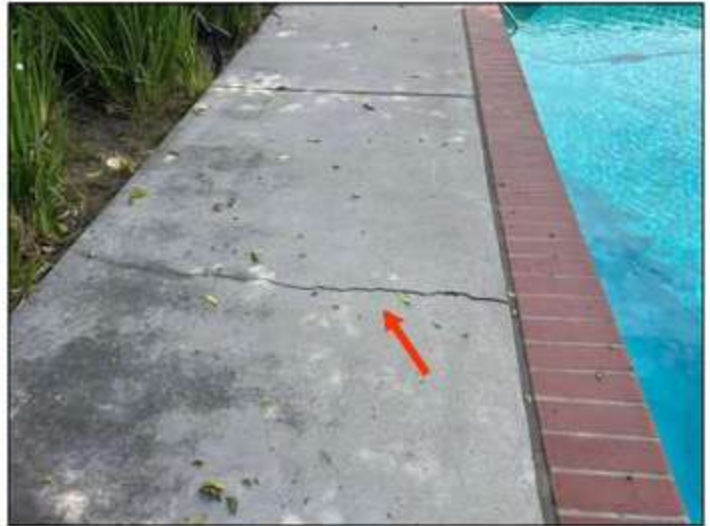
Pool deck has visible crack(s) at various areas (2), recommend further review and repair by licensed pool contractor to repair/replace pool concrete deck (2).

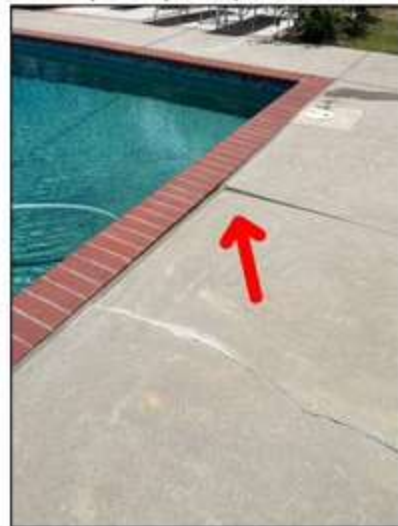
Concrete pool deck has settled area creating tripping hazard (4)\*, recommend repair.

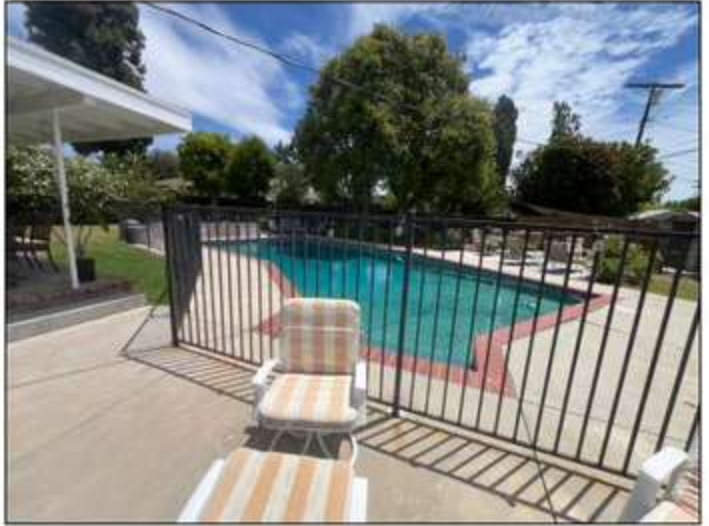
(pool fence latch nf) Pool barrier/fence gate does not properly self close/self latch as required by current safety standards (4), safety hazard. Recommend subsequent repair, adjustment, replacement of self latching gate mechanism as required by current safety standards (2).

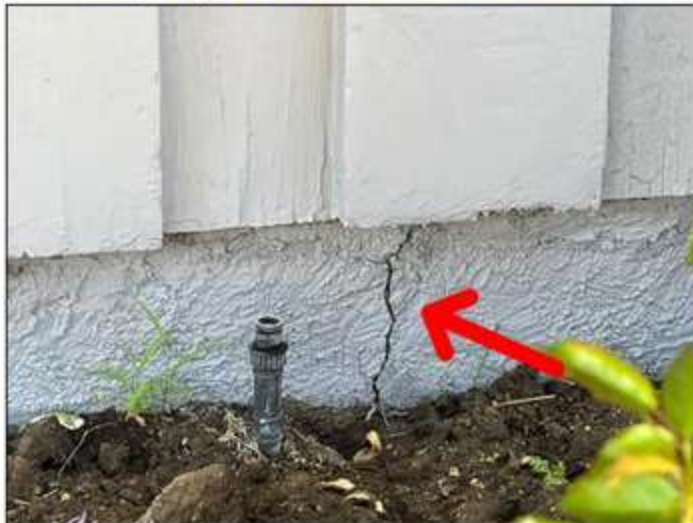
(west) Foundation has visible crack located on west side of property (2), recommend further review and repair by a licensed foundation contractor. Location: Garage foundation

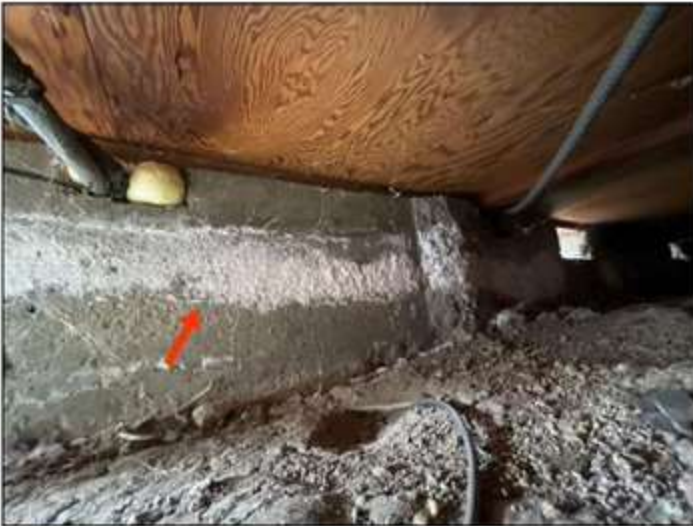
(efflorescence) The raised concrete foundation has visible efflorescence present at various stem foundation walls in foundation crawlspace \*. Efflorescence is caused by improper side drainage allowing moisture/water to enter into foundation walls creating mineral deposits which can damage foundation structure.

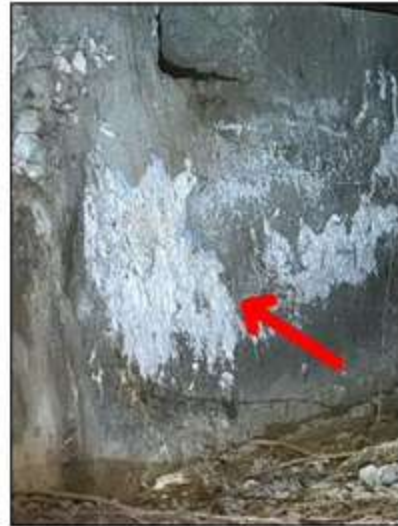
(foundation spalling) The raised concrete foundation has age related wear caused by improper site drainage creating efflorescence and deteriorating concrete foundation known as spalling (2). Recommend further review and repair by licensed foundation contractor. The properties age has contributed to the foundation issues as well as in proper site drainage (2).

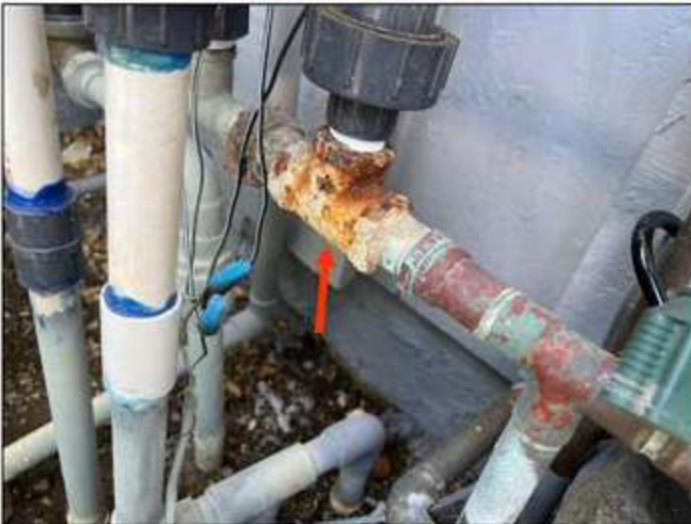
Water supply line at front of property is galvanized and has major rust damage (2), recommend further review repair by licensed plumber.

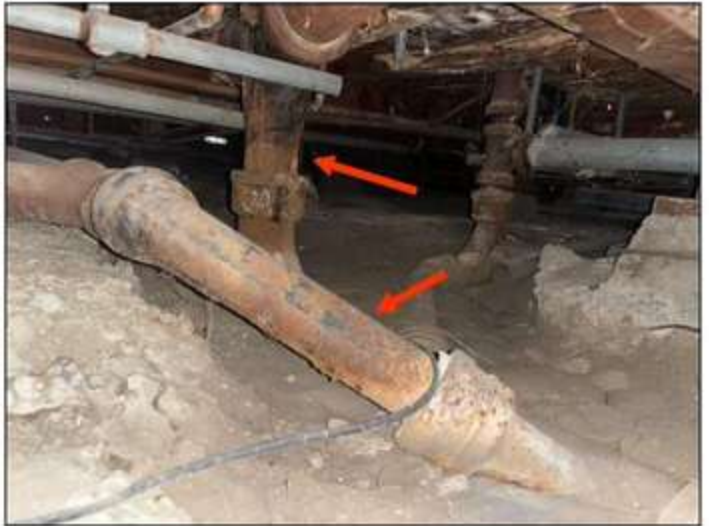
Subject property does not have a sewer clean out located at front of property as required (5). Inspector viewed Sewer system underneath foundation crawlspace and it appears to be routed towards the front of property. The main lateral sewer pipe appears to wrap around the property traveling north to rear yard. There is a 4 inch ABS sewer clean out located at rear property approximately 20 feet from structure. Due to the missing clean out at the front, inspector was not able to view or inspect the main lateral sewer pipe located from the front of the structure to the clean out at rear. Recommend having licensed plumber pull a toilet and inspect sewer main lateral pipe with camera from the structure to the clean out area located at rear of property (2).

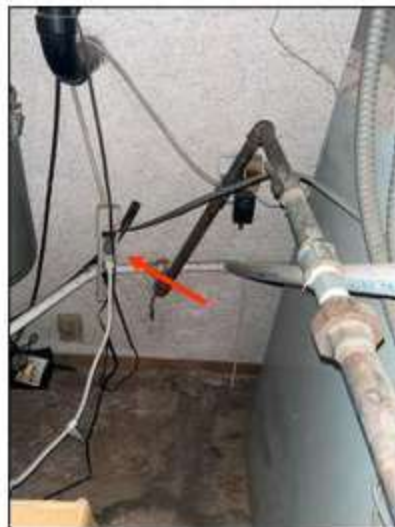
The HVAC furnace electrical cord is installed on an extension cord \*(2), it is not recommended to connect the HVAC system on an extension cord. Recommend installing electrical outlet at this area to service HVAC furnace as required by current standards.

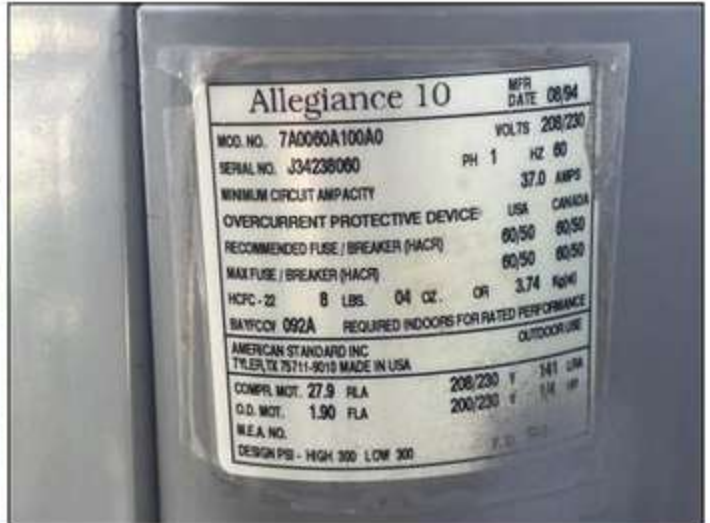
HVAC Compressor MFG Date: 1994  
 (R-22) HVAC compressor installed at property is charged with R-22 and or HCFC-22 refrigerant. R-22 type of refrigerant is banned as of 2020. EPA states that you can continue to use your system that contains R-22 refrigerant after 2020. The issue is if you need HVAC service, The HVAC service may be more costly and or may not be able to find refrigerant. Only options is do nothing and use HVAC system till it needs service and repair and or replace system preemptively. Systems that use R-22 Refrigerant are manufactured before 2010 and may be less efficient as newer systems. Information described is a Disclaimer on R-22 refrigerant. Consult Licensed HVAC contractor for further review (2).

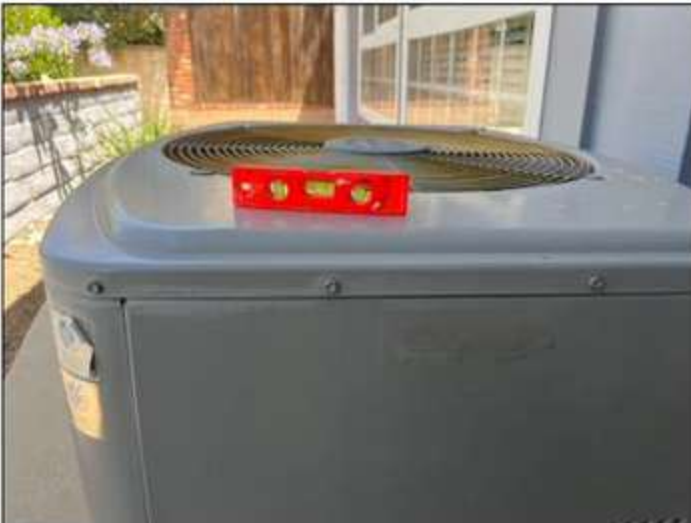
(not level) HVAC compressor is not level \*(2), compressor fan requires level platform for proper function of compressor components. Having a compressor that is not level will prematurely wear compressor components. Recommend repair.

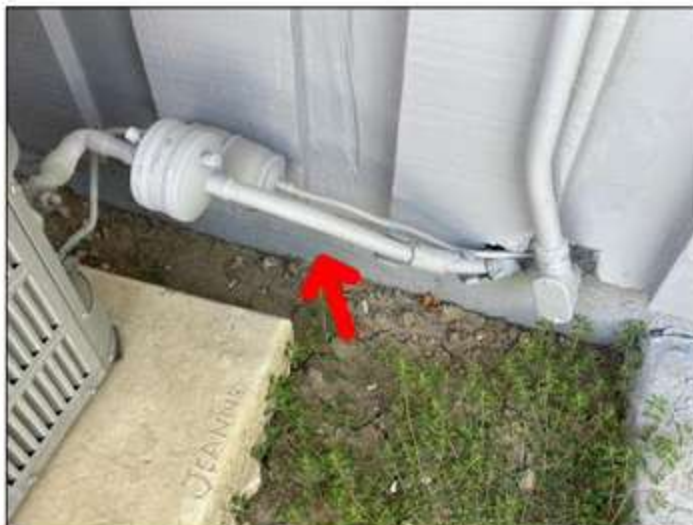
Refrigerant at compressor had damaged/worn insulation \*, recommend having insulation replaced.

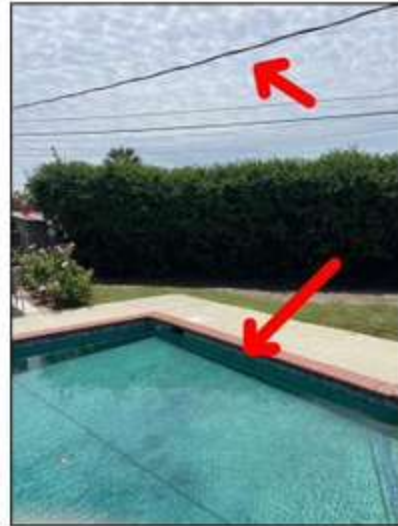
Main electrical overhead service wire comes to close to pool (2), main electrical service wire should have proper distances from pool by current standards. Recommend further review and repair by licensed electrical contractor.

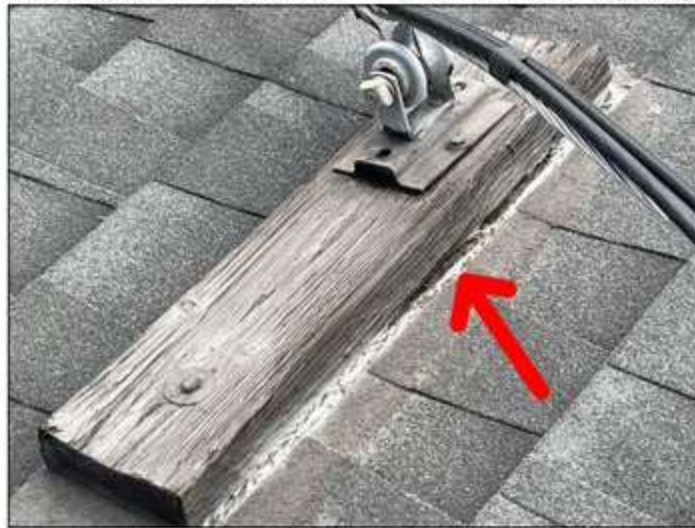
The main electrical service line attachment wood base has lifted away and may allow moisture intrusion \*(2), recommend repair to prevent moisture intrusion when it rains.

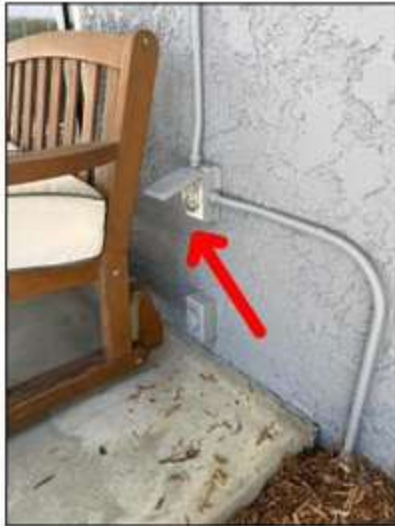
(ext gfci trip) Exterior GFCI located at rear patio did not shut off/trip when tested (4)(2), safety hazard. Recommend further review and repair by licensed electrical contractor.  
Location: Rear patio

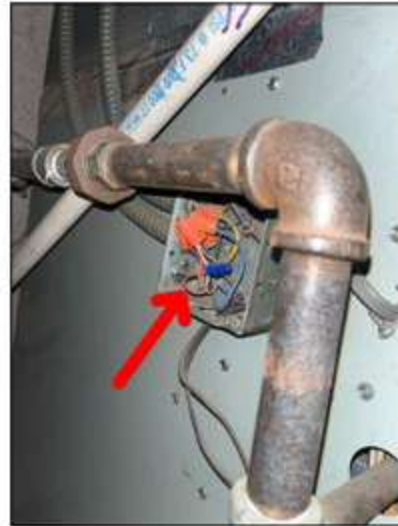
Electrical junction box located at HVAC furnace area is missing cover \*.

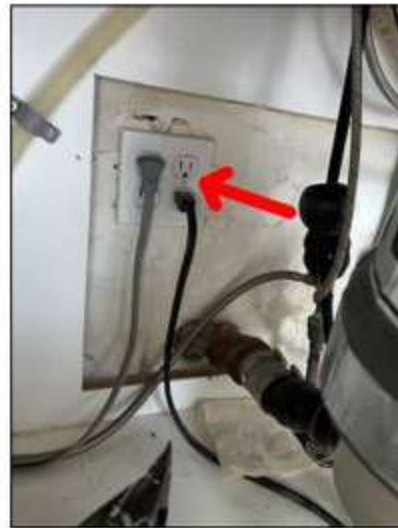
(gfc under sink) GFCI electrical outlets are required under kitchen sink (5)(2), recommend installing GFCI electrical outlets under kitchen sink as an upgrade. GFCI (Ground Fault Circuit Interrupter) outlets are required at kitchens to enhance electrical safety by reducing the risk of electric shock in wet environments. Even if a property was built before current standards mandated GFCI installation, upgrading to these outlets is crucial for ensuring safety and compliance with modern electrical codes. Retrofitting older properties with GFCI outlets not only protects occupants but also aligns the home with contemporary safety practices.

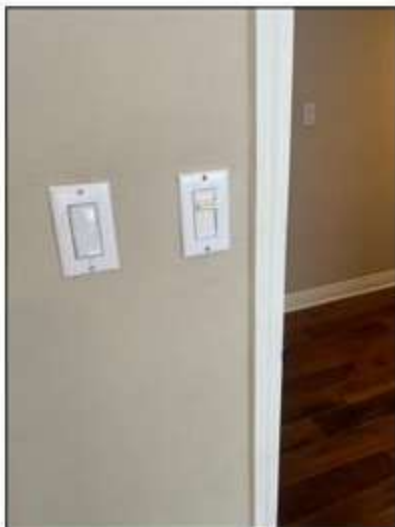
Bedroom #1 dimmer light switch on right side is non-function \*(2).

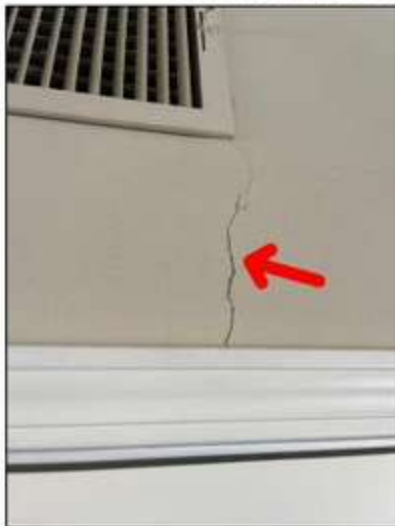
Main hallway closet Wall is cracked over door header \*(2).

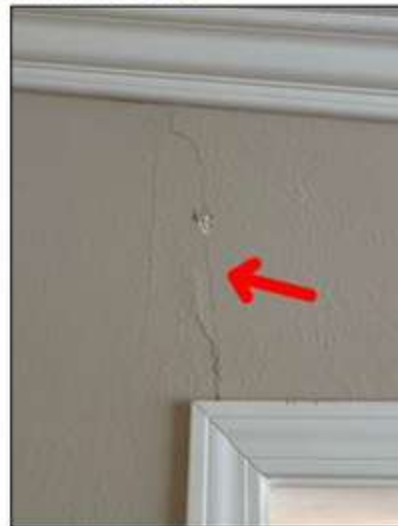
Living room Wall is cracked located on south side at door header (2).

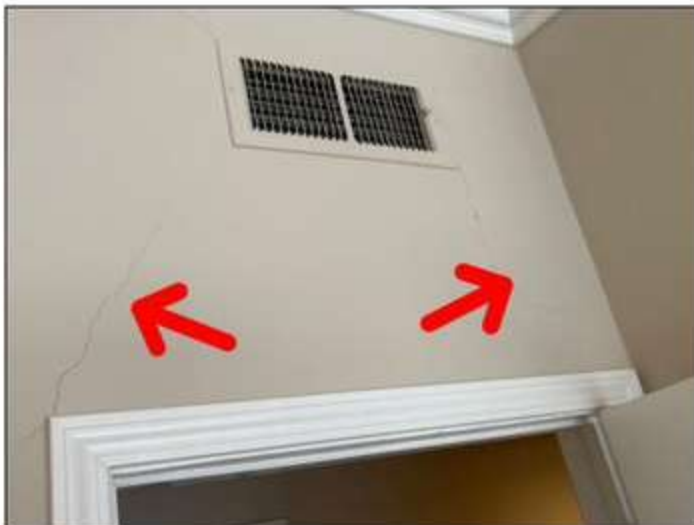
Bedroom #1 interior door header is cracked \*(2).

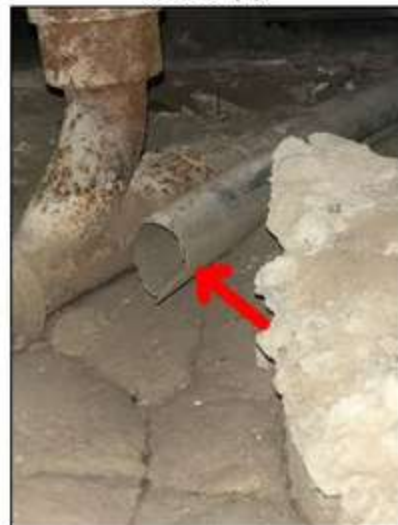
The whole house vacuum system piping/ducting in foundation crawlspace is nonfunctional and cracked at various areas \*. Recommend re-installing piping/ducting if you would like to use whole house vacuum. Whole house vacuum was not tested \*.

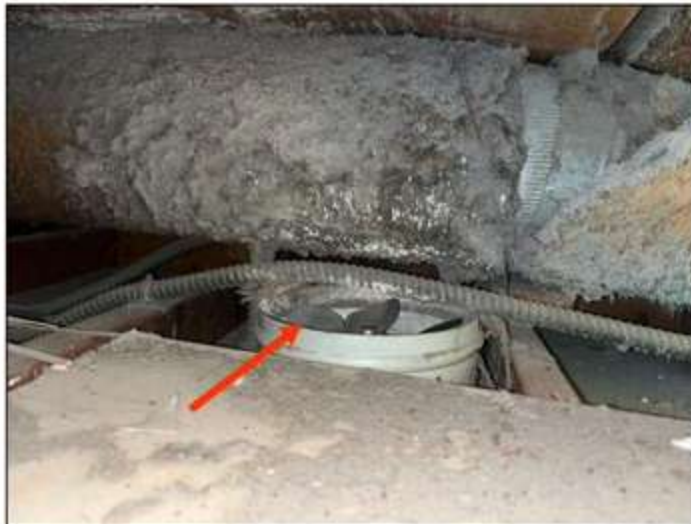
Laundry room exhaust vent does not have a duck to route exhaust to the exterior \*. Also the fan does not have a cover or some type of insulation that will prevent heat from attic to enter into house \*. Recommend further review repair by licensed contractor.

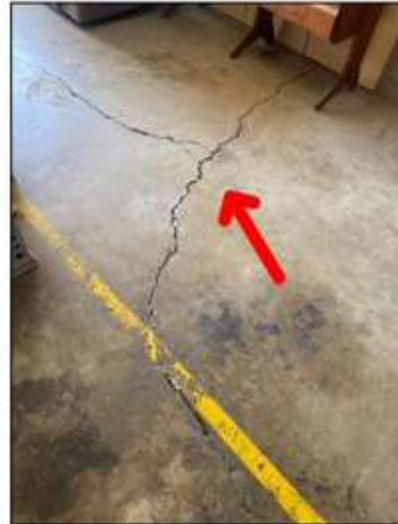
Garage concrete floor had various major cracks, recommend repair (2). Recommend further review and repairs as needed by a qualified licensed contractor or specialty tradesman dealing with this item or system.

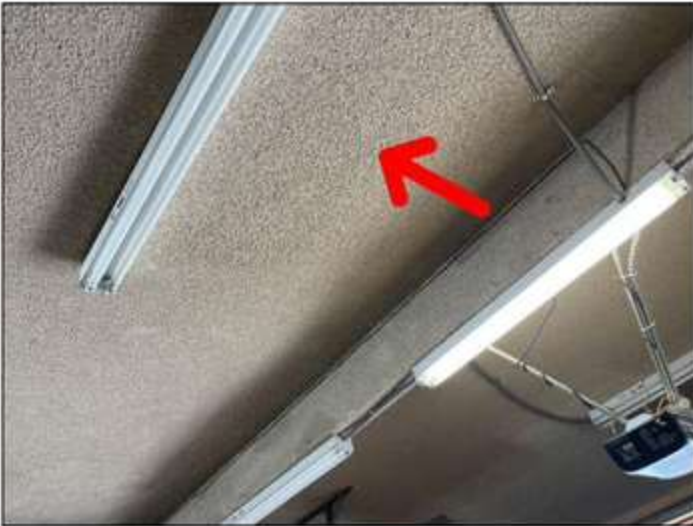
Acoustical ceiling at property may contain materials that are dangerous if scraped and inhaled (2)(4), if buyer is removing the acoustical ceiling, acoustical ceiling should be tested for the presence of Asbestos. The property was built before 1975 and was built in the era of asbestos products being used. When removing acoustical ceiling it is recommended to use a licensed abatement contractor to remove acoustical ceiling. Location: Main hallway closet, garage, laundry room, and bedroom closets.

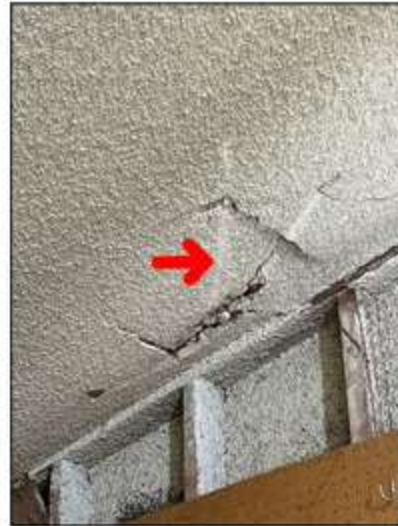
Garage ceiling is damaged located on SW corner \*.

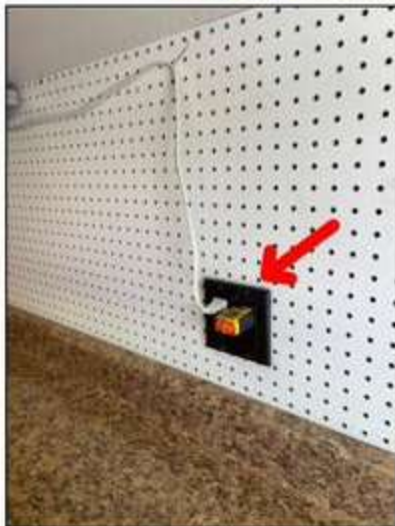
(no gfci) GFCI electrical outlets are not installed in garage (5). Recommend installing GFCI electrical outlets as required by current standards as a safety upgrade (5). GFCI electrical outlets are required to be installed in garage at any electrical outlet that services garage that is not dedicated to an appliance. Recommend installing as a safety upgrade. GFCI (Ground Fault Circuit Interrupter) outlets are required in garage to enhance electrical safety by reducing the risk of electric shock in wet environments. Even if a property was built before current standards mandated GFCI installation, upgrading to these outlets is crucial for ensuring safety and compliance with modern electrical standards. Retrofitting older properties with GFCI outlets not only protects occupants but also aligns the home with contemporary safety practices.

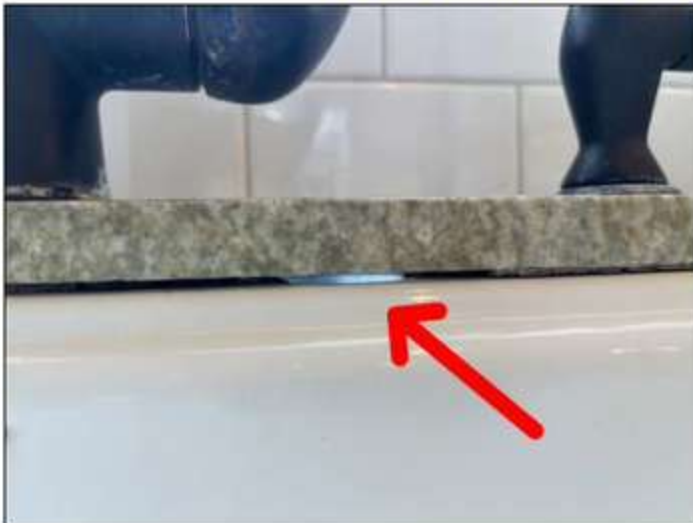
Undermount kitchen sink has visible gap at attachment under granite counter (2), this gap will allow moisture to leak under kitchen sink. Recommend repair as necessary.

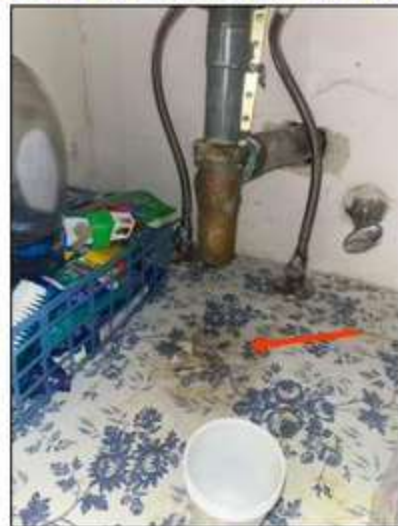
Bathroom (B) sink drain has active leak (2), moisture stain at base of kitchen counter. Recommend further review and repair by licensed plumber.

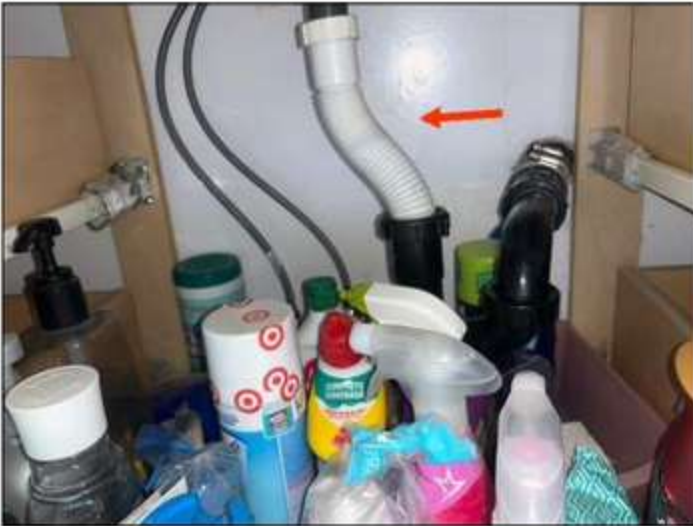
(flex drain A) Bathroom (A) sink drain has a flex extension form fit drain installed which is not approved in most areas (2), recommend further review and repair by licensed plumber.

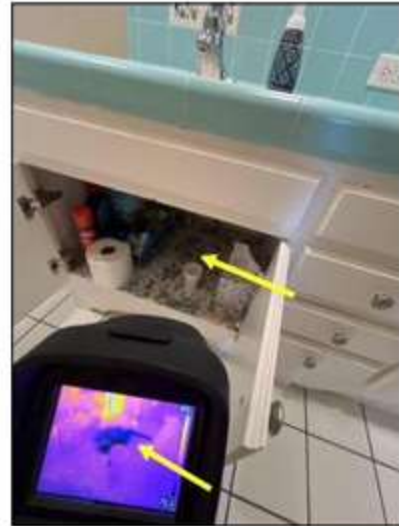
Bathroom (B) sink drain has active leak (2), moisture stain at base of kitchen counter. Recommend further review and repair by licensed plumber. The thermal imaging camera was used to inspect area which detected active leak.

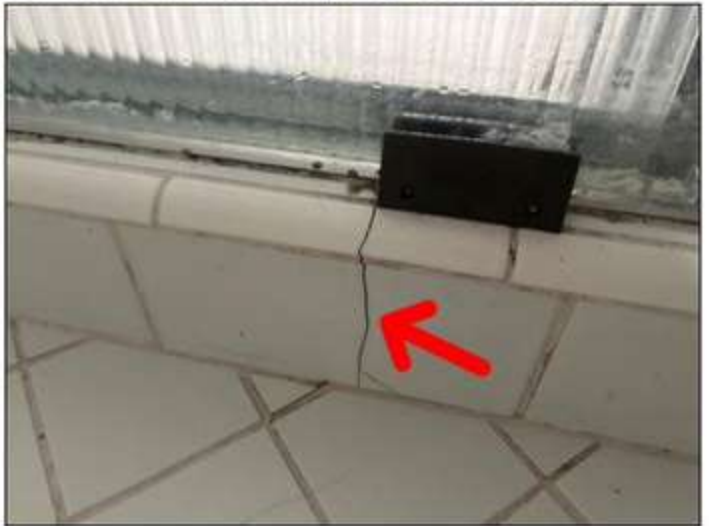
Bathroom (A) tile shower enclosure curb has visible crack at both sides of curb (2), the crack may allow shower pan to leak. Recommend further review repair by licensed contractor.
