# Guardian Home Inspection, Inc

## Property Inspection Report

12345 Main St. , Awesome Town , CA. 90000  
Inspection prepared for: Sample Inspection Report  
Real Estate Agent: Realtor Name -

Date of Inspection: 1/1/2025  
Inspector: Angel "Frank" Garcia

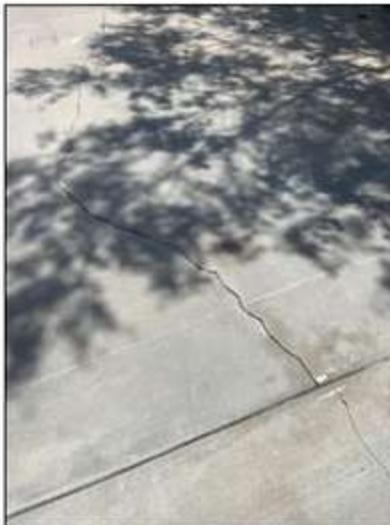
Driveway had common cracks \*, Appears serviceable.

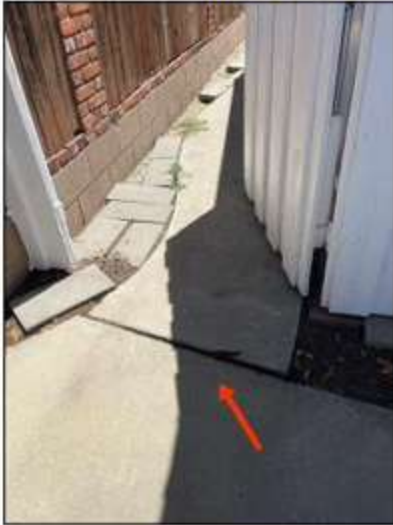
(step off trip front ) Concrete sidewalk has step off at joint(s) causing trip hazard located at front of property \*(4), recommend repair as a safety upgrade. Consult licensed contractor for further review and repair.

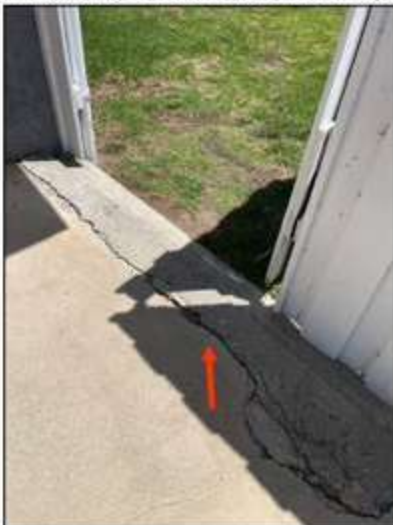
Rear concrete sidewalk is cracked \*.

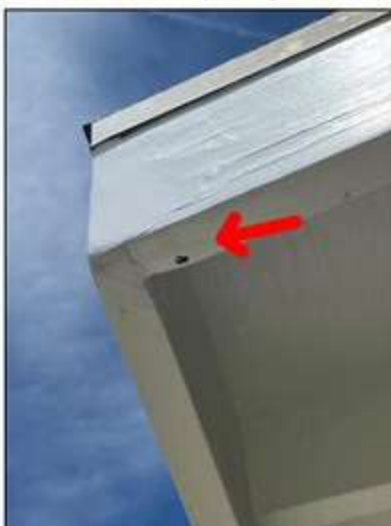
(Fascia (3) SE) Exterior wood fascia located on SE corner has moisture/termite damage (3), recommend further review and repair by licensed termite inspector.

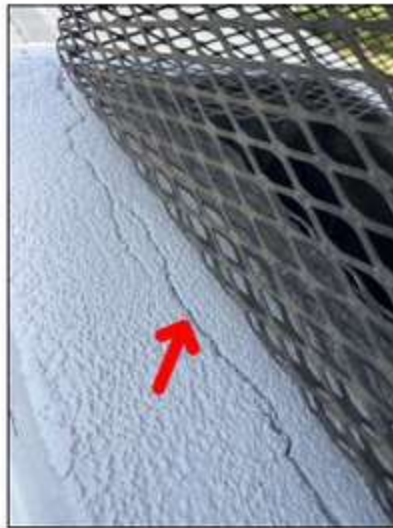
(crack crown) Chimney rain masonry cap/crown is cracked which will allow water to enter into inner chimney brick and mortar which prematurely age chimney deteriorating structure (2), recommend repair.

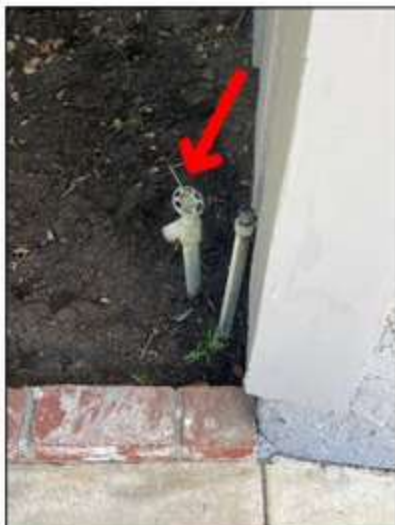
Exterior hose faucet is non-functional located at SW corner \*. It appears that the property was re-piped with copper. This hose faucet may be abandoned.

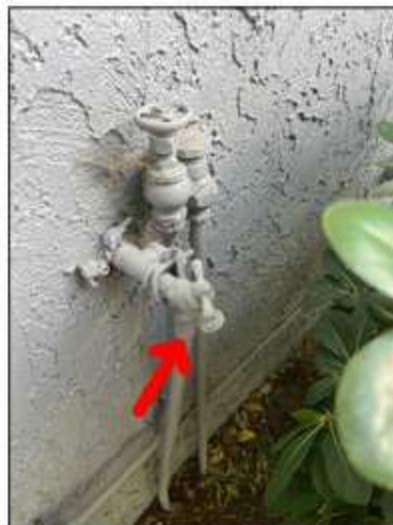
Exterior rear hose faucet is non-function \*(2).

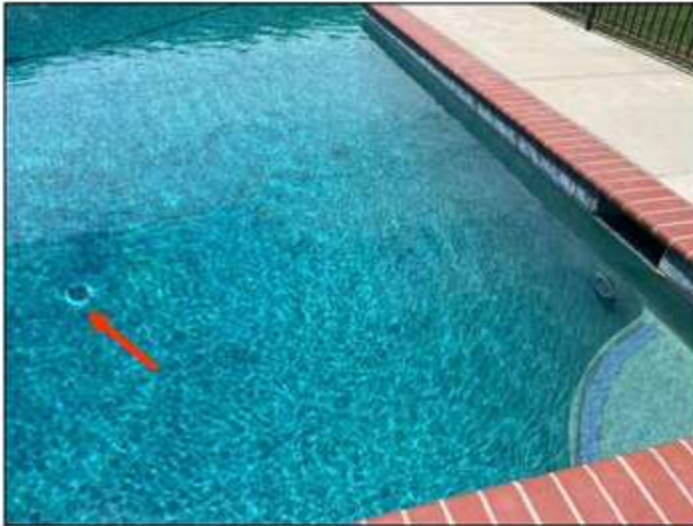
(missing proper Cover) Pool drain at the deep end is missing proper anti-vortex cover (5), proper pool drain covers are required to be installed as a safety upgrade. Current standards require two separate anti-vortex pool drain covers.

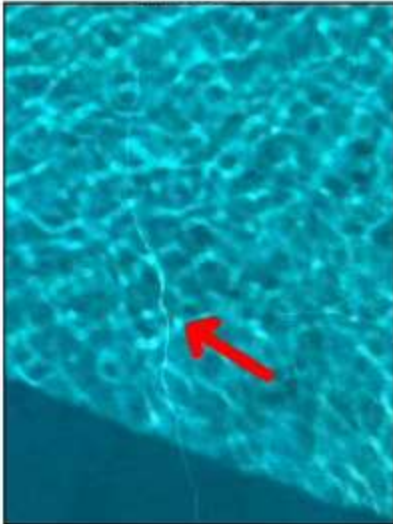
Pool body plaster has a visible crack/fracture in the middle section of the pool plaster, in addition a water hose placed inside the water suggests an active effort to compensate for water loss (2). The pool appears to be leaking, recommend further review repair by licensed pool contractor.

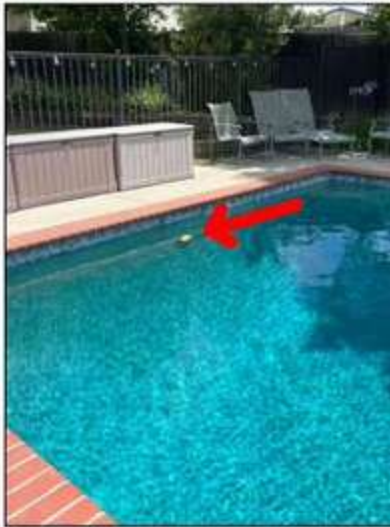
Pool/Spa light GFCI electrical receptacle did not trip circuit as required (2)(4), recommend replacing GFCI electrical receptacle as required by current standards.

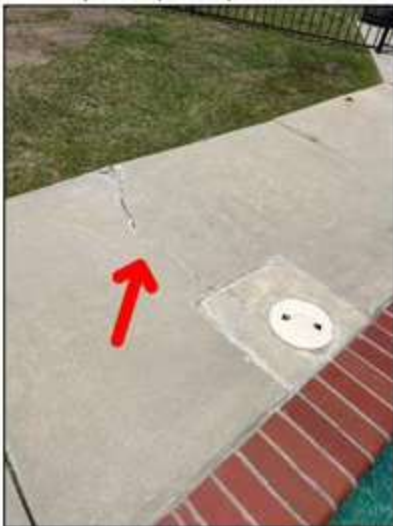
Pool deck has visible crack(s) at various areas (2), recommend further review and repair by licensed pool contractor to repair/replace pool concrete deck (2).

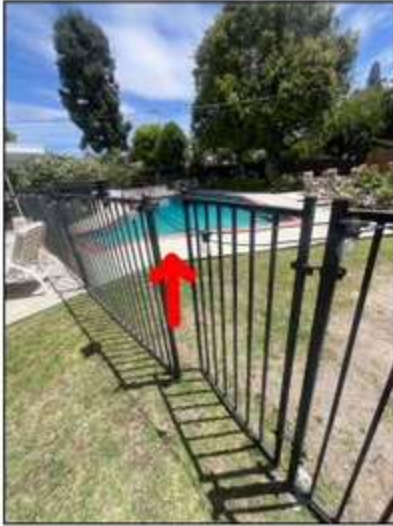
(pool fence latch nf) Pool barrier/fence gate does not properly self close/self latch as required by current safety standards (4), safety hazard. Recommend subsequent repair, adjustment, replacement of self latching gate mechanism as required by current safety standards (2).

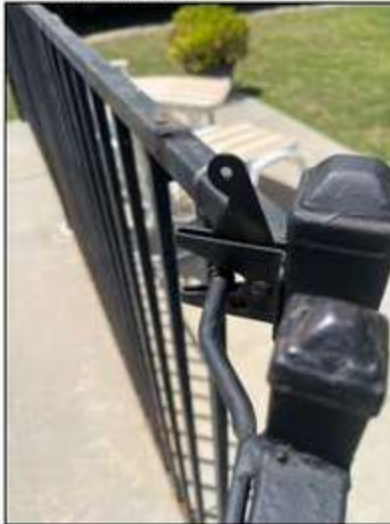
Both Pool barrier/fence gates do not properly self close/self latch as required by current safety standards (4), safety hazard. Recommend subsequent repair, adjustment, replacement of self latching gate mechanism as required by current safety standards (2).

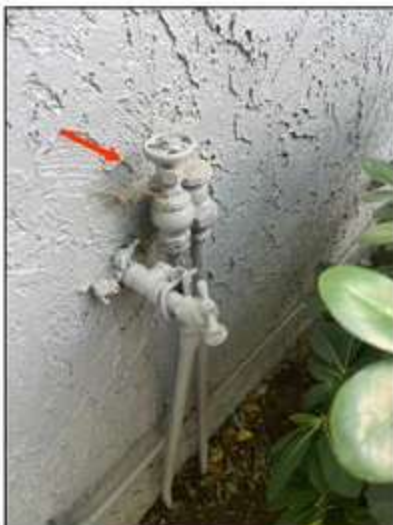
Pool water fuel valve was tested and it did not appear to nonfunctional \*, recommend further review repair by licensed plumber.

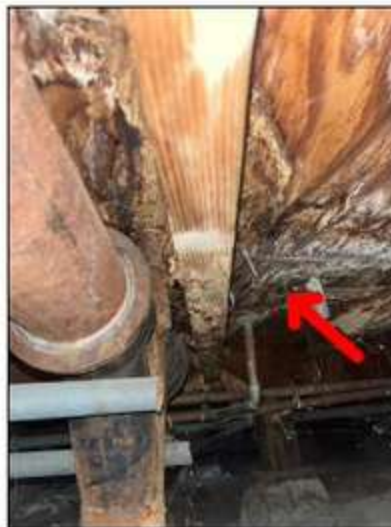
Wood Subfloor has visible moisture staining/damage located at bathroom (A) toilet area visible in foundation crawlspace (3).

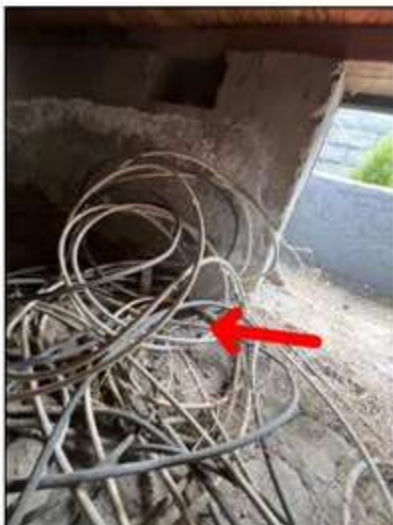
Excessive TV cable wire abandoned in foundation crawl space \*, recommend removal as necessary.

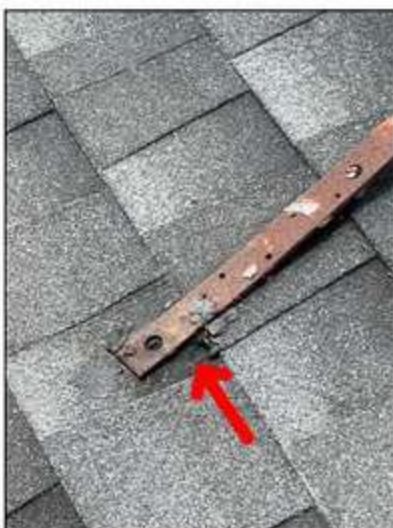
Chimney attachment bracket installed on roof is not properly sealed with roofing mastic to prevent moisture intrusion \*, recommend repair to prevent moisture intrusion.

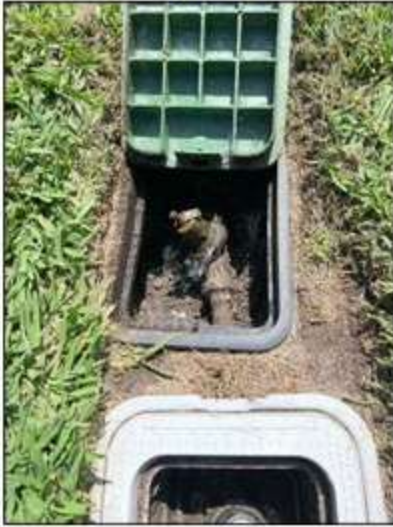
Pressure regulator installed at front of main water supply at meter area.

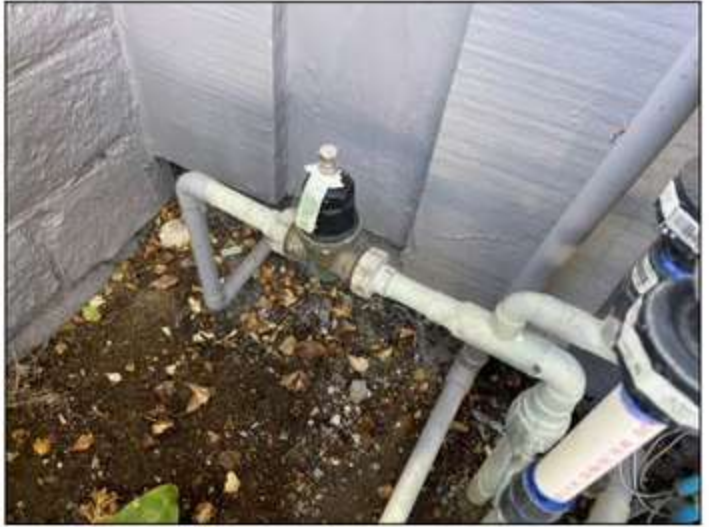
Main water supply pipe pressure regulator installed, appears serviceable.

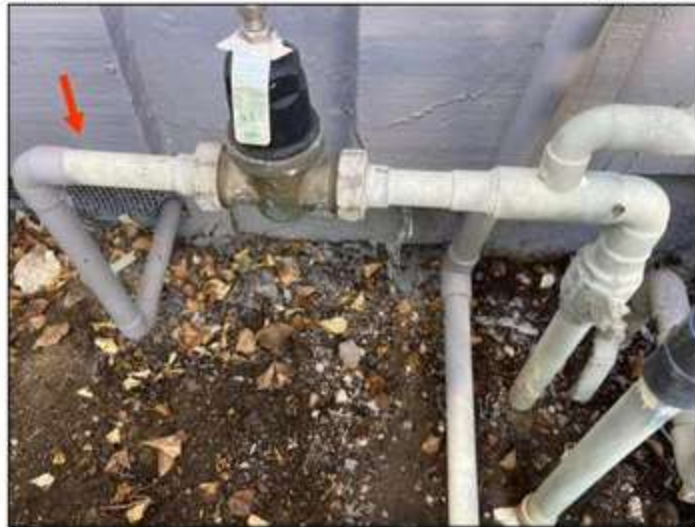
(no pressure exhaust) Main water supply pipe does not have a pressure exhaust installed as required (2), recommend installing. Recommend further review and repair by licensed plumber.

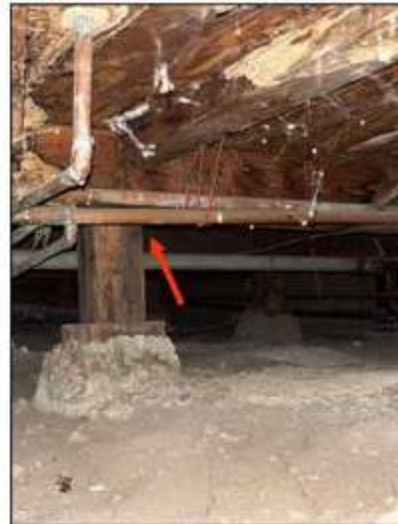
(H not insulated) Hot water supply pipes are not insulated in attic/foundation crawl space \*, recommend adding insulation as an upgrade for higher efficiency.

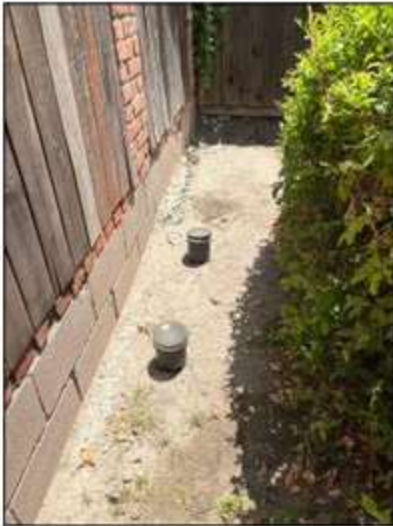
Subject property does not have a sewer clean out located at front of property as required (5). Inspector viewed Sewer system underneath foundation crawlspace and it appears to be routed towards the front of property. The main lateral sewer pipe appears to wrap around the property traveling north to rear yard. There is a 4 inch ABS sewer clean out located at rear property approximately 20 feet from structure. Due to the missing clean out at the front, inspector was not able to view or inspect the main lateral sewer pipe located from the front of the structure to the clean out at rear. Recommend having licensed plumber pull a toilet and inspect sewer main lateral pipe with camera from the structure to the clean out area located at rear of property (2).

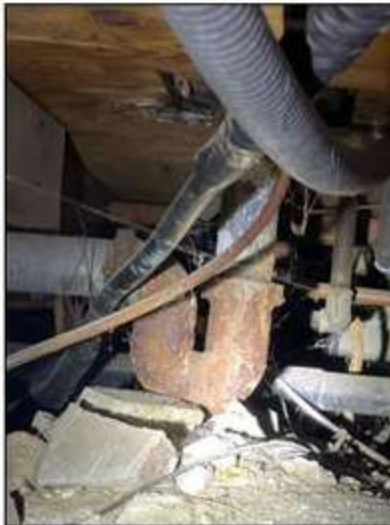
Main sewer line is cast iron \*, Original cast iron sewer pipes may become an issue due to age (2). Cast iron sewer pipes can last 50–100 years, but some say they can last much longer. However, it's normal for them to start to deteriorate after 25 years. To avoid major issues, homeowners should regularly inspect their pipes for signs of trouble, such as: Rusting, Decaying, Discoloration, Cracking, and Sporadic leaks. If property sewer pipe is cast iron and property is older than 25 years, the chances of cast iron sewage pipe issue is higher. Using a sewer snake may crack and damage rusted/older cast iron sewer pipe. Recommend replacing cast iron sewer pipe to ABS due to age and as an upgrade.

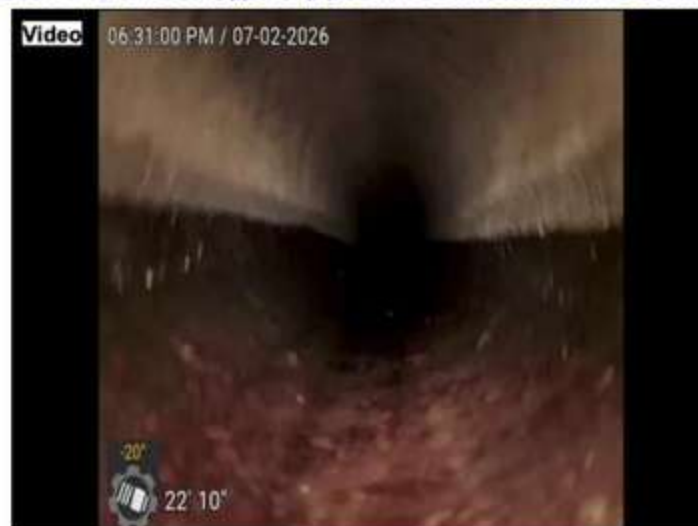
Main sewer pipe material is Vitrified clay pipe (VCP), or clay tile pipe. Vitrified clay pipe (VCP), or clay tile pipe, is made from a blend of clay and shale, set at a high temperature to turn the pipe into an inert ceramic. This type of pipe is regularly used in gravity sewer collection mains because it resists most sewage and has a long lifespan. Unfortunately, VCP pipes are the most susceptible to root infiltration. Because clay pipes are joined with hubbed fittings, they do not provide a reliable seal against water. Tree roots are attracted to the water leaking through the joints, and the result is often sewer line damage. To avoid having to replace your pipes, we suggest a bi-annual sewer cleaning. This process rids the system of roots before they become a serious concern. The majority of sewer pipes installed at homes including the main lateral sewer pipe may have different types of pipes, this will be reason why different type of pipes will be checked at this section.

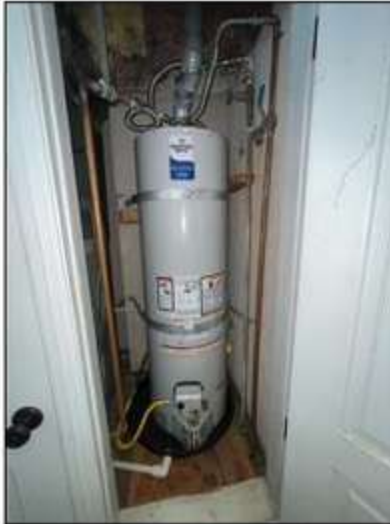
Water heater appears serviceable, see sections below for other notes and or issues with water heater.

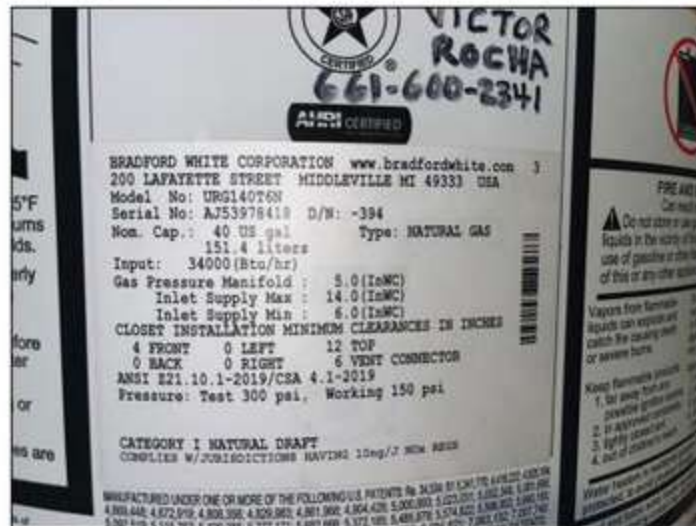
Water heater MFG brand: Bradford White MFG DATE: 2024

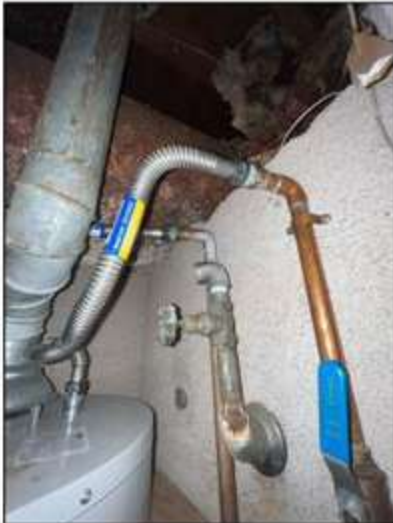
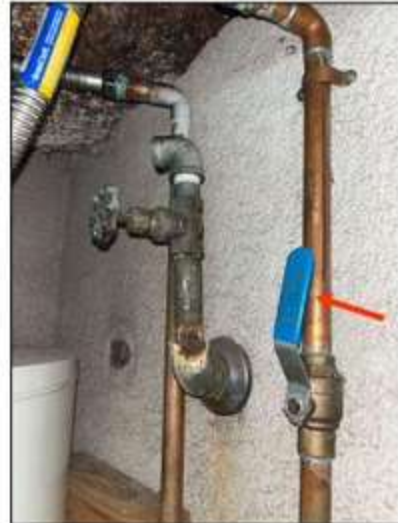
(bond not installed) Water heater water supply pipes do not have bonding conductor installed as required by current standards (5), recommend installing as a safety upgrade.

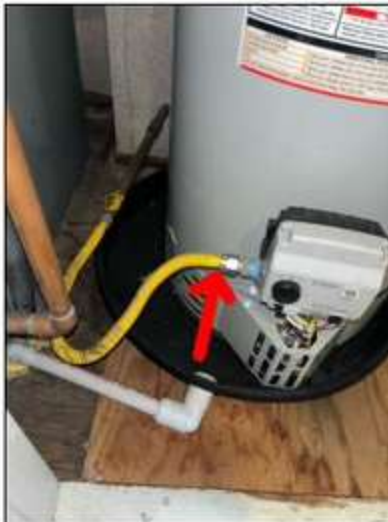
(drip leg) Gas supply pipe to water heater does not have a proper drip leg installed as required by current standards (5), recommend repair as an upgrade.

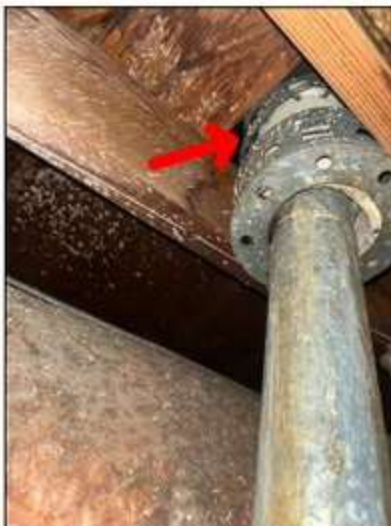
Water heater vent flue is connected to a single walled vent flue that is Transite and is known to contain asbestos, single walled vent flue is routed through attic (5), safety hazard. Recommend replacing vent flue pipe for safety upgrade (5).

Recommend further review and repair by a licensed plumbing contractor. The property was built before current standards, recommend repair as an upgrade (5).

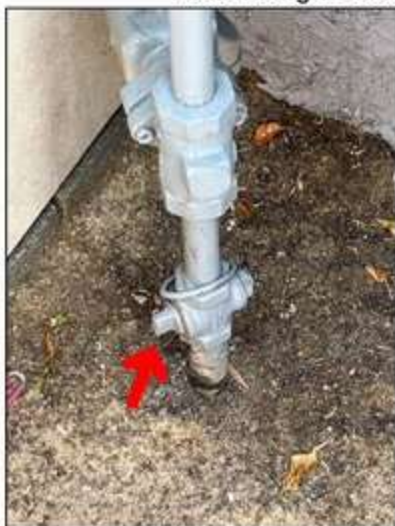
(AS shut off) Main gas supply shut off valve present and fully visible, appears serviceable.  
To shut off main gas supply valve: Use a 12-inch or larger adjustable wrench to turn the valve a quarter turn clockwise, or until it's perpendicular to the pipe. The valve is closed when the tang, or part of the valve you turn with the wrench, is crosswise to the pipe.

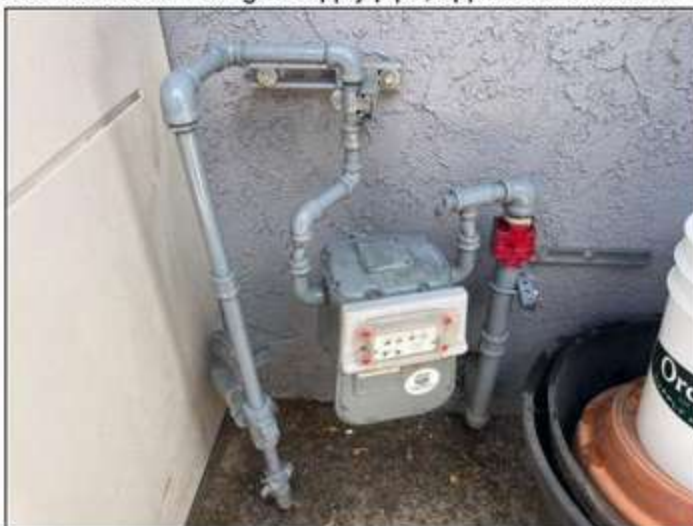
(North) Main gas supply meter is located on north side of property. Main gas supply shut off valve installed, appears serviceable.

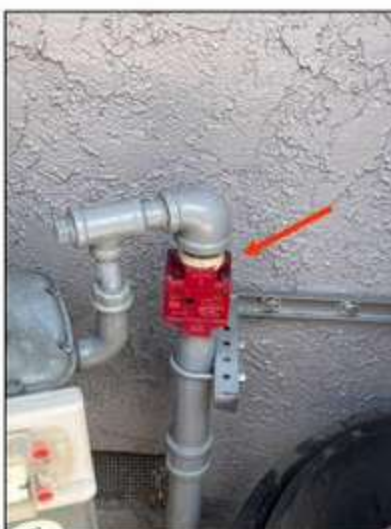
Automatic gas seismic shut off valve installed at main gas supply pipe, appears serviceable.

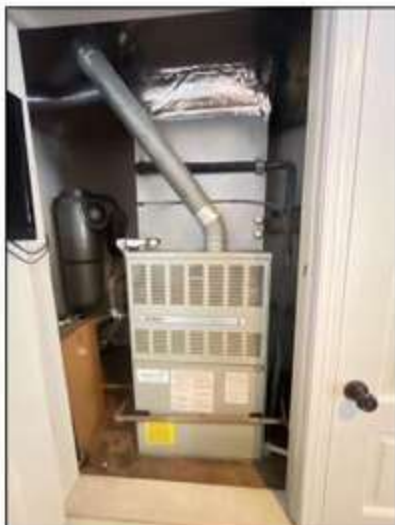
HVAC furnace installed is functional, but may have other issues present. See notes below for further information.

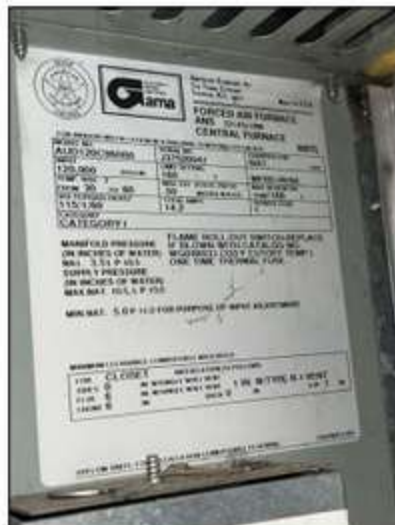
HVAC furnace MFG date: 1994

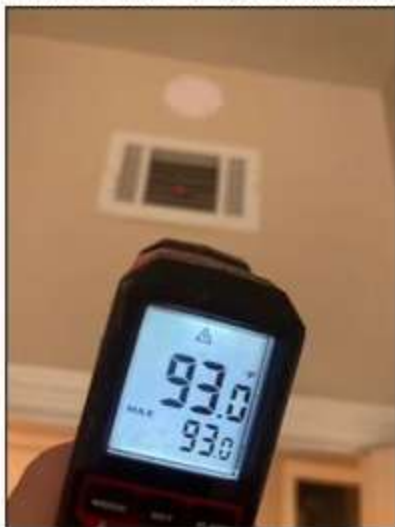
(normal temp) HVAC temperature on heating mode is 93°F, appears serviceable.

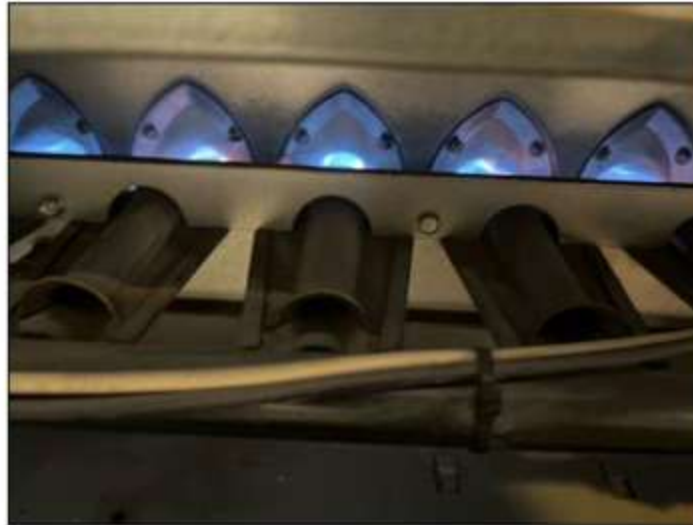
Furnace burner flame appears typical.

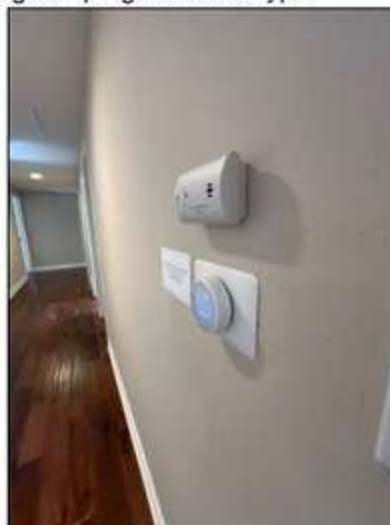
Thermostat located at main hallway.

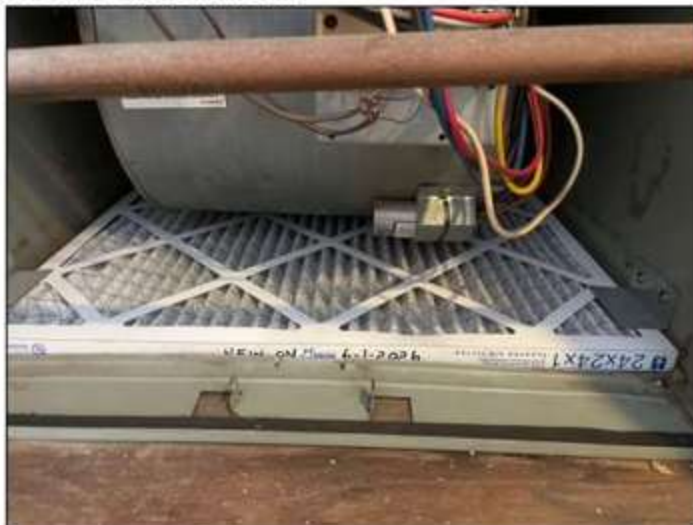
Air filters at property appear serviceable, Recommend replacing filter at least twice a year, start of summer and start of winter.

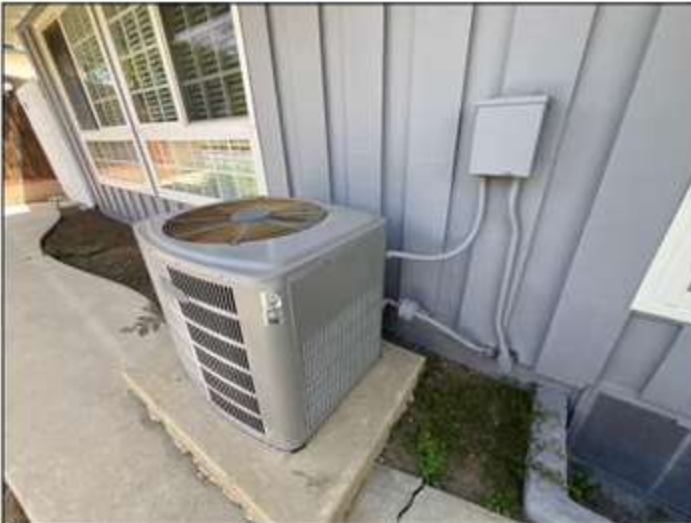
(W) HVAC Compressor located at: Exterior south side, see notes below for other issues noted.

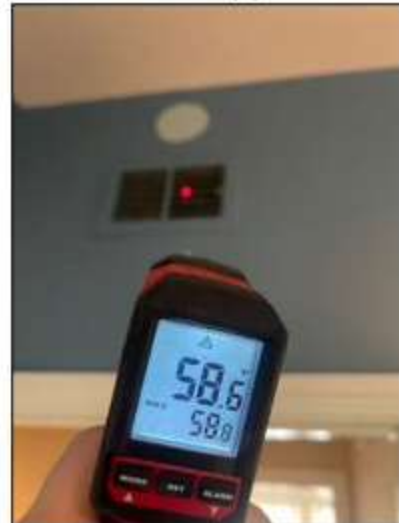
(temp) HVAC temperature on cooling mode was 58°F, appears serviceable.

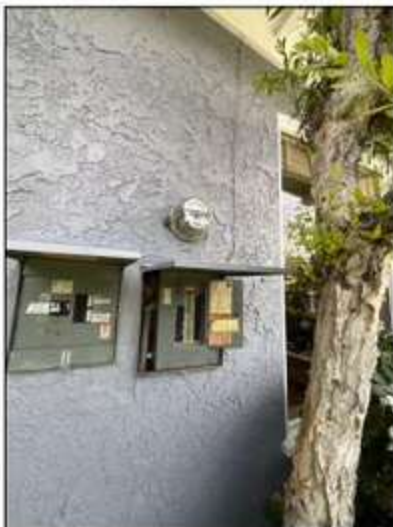
(south) Main electrical panel is located at exterior south side of property.

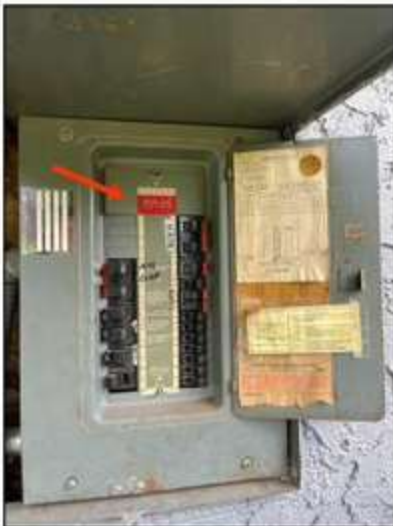
(FPSL) Main electrical panel is a Federal Pacific Stab-LOK panel (4)(2), Federal Pacific Stab-LOK panels are older panels that do not have parts for and or known to have numerous problems with performance. The panel breakers do not have proper connections and may arc creating a fire hazard and are also known for breakers not tripping/shutting off when needed (4). These panels are considered a safety hazard and should be replaced, consult a licensed electrical contractor for further review and repair. Some home owners insurance may not cover a claim resulting from issues with this type of panel.

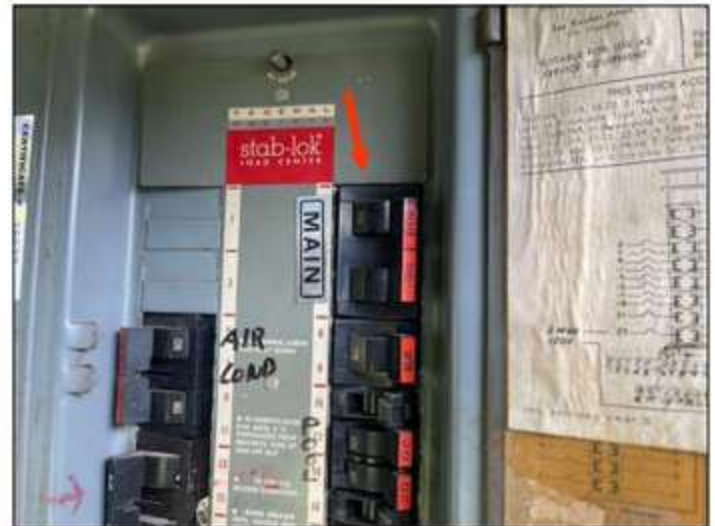
Main electrical panel service disconnect located at arrow, in case of emergency move MAIN BREAKER to "OFF" position.

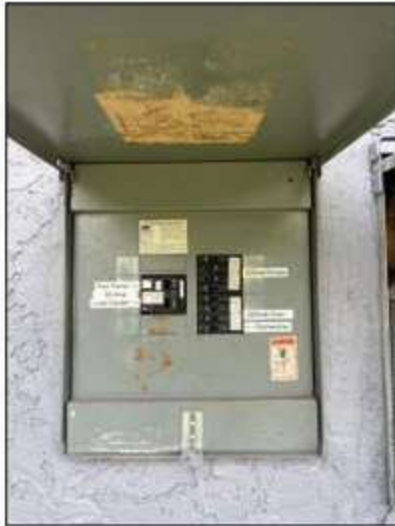
Sub electrical panel installed at exterior south side appears serviceable.

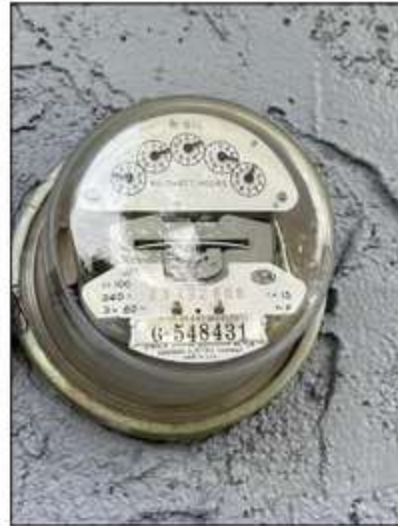
Electrical service main electrical panel Meter: 6- 100 amp meter installed, appears serviceable.

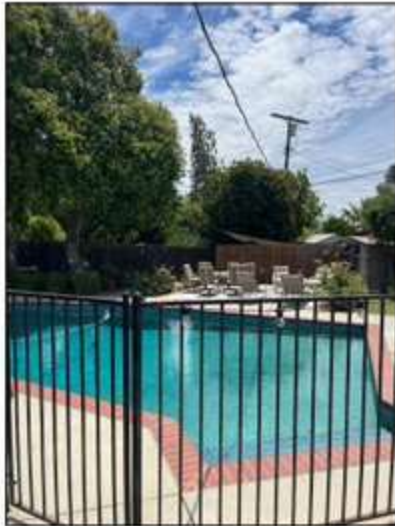
Main electrical overhead service wire comes to close to pool (2), main electrical service wire should have proper distances from pool by current standards. Recommend further review and repair by licensed electrical contractor.

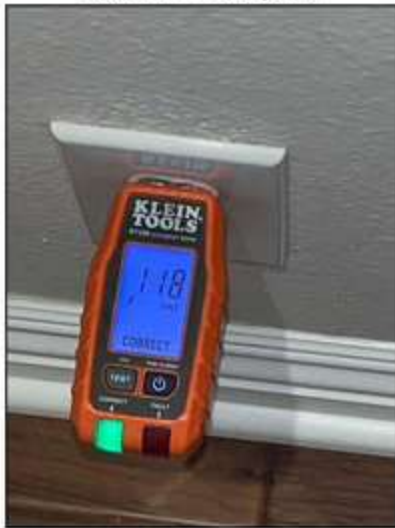
A fair of number of electrical outlets were tested at the time of the inspection for correct voltage, the electrical outlets tested at 120 Volts which appears serviceable.

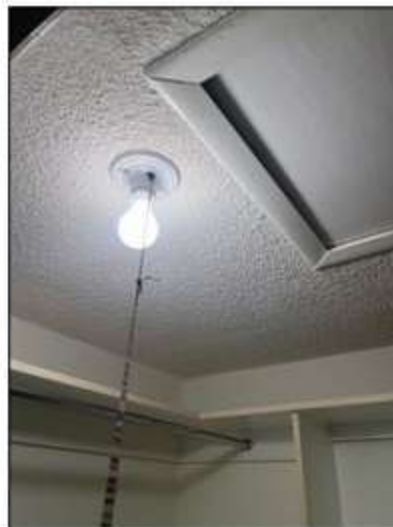
Bedroom #2 closet has a temporary ceramic light fixture without a proper cover install installed \*(5). Recommend installing a modern light fixture as an upgrade.

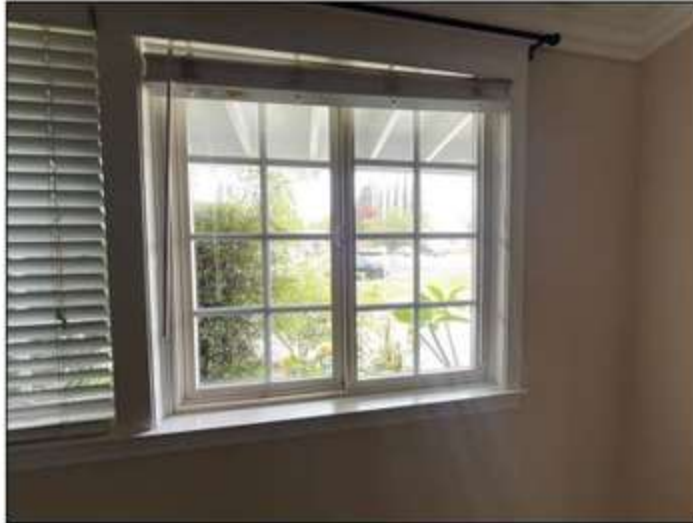
Vinyl replacement, dual pane, sliding. \*\*Vinyl replacement windows are installed into original opening with out damaging stucco, in various cases the windows are installed by home owner or person with out proper knowledge of proper flashing installation. Inspector will not be able to detect proper installation of windows present. Vinyl replacement windows may leak when it rains \*, inspection is limited.

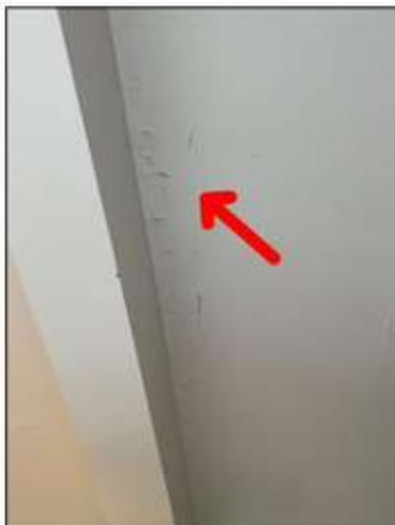
Chipped paint at kitchen ceiling \*.

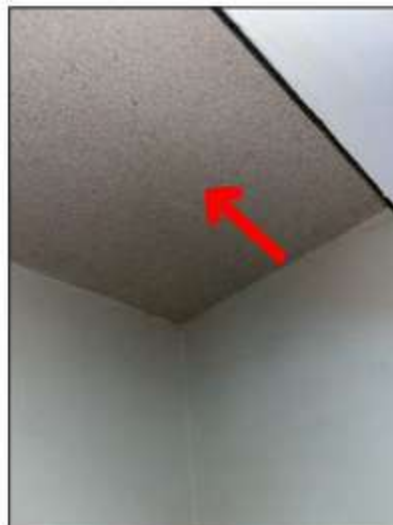
Acoustical ceiling at property may contain materials that are dangerous if scraped and inhaled (2)(4), if buyer is removing the acoustical ceiling, acoustical ceiling should be tested for the presence of Asbestos. The property was built before 1975 and was built in the era of asbestos products being used. Whenever removing acoustical ceiling it is recommended to use a licensed contractor to remove acoustical ceiling. Location: Main hallway closet, garage.

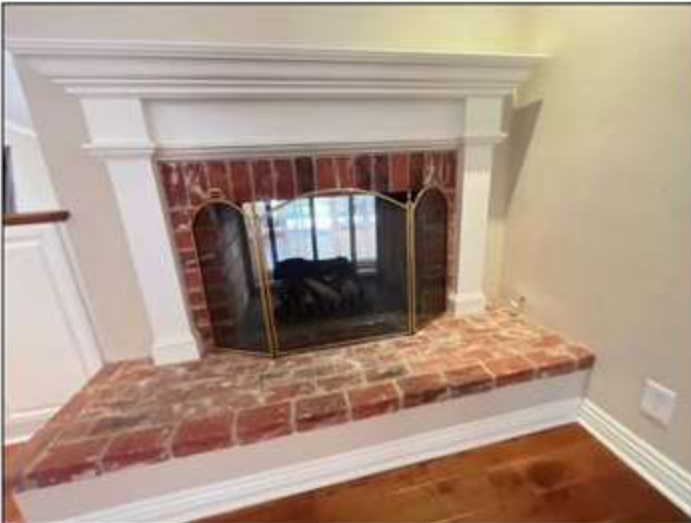
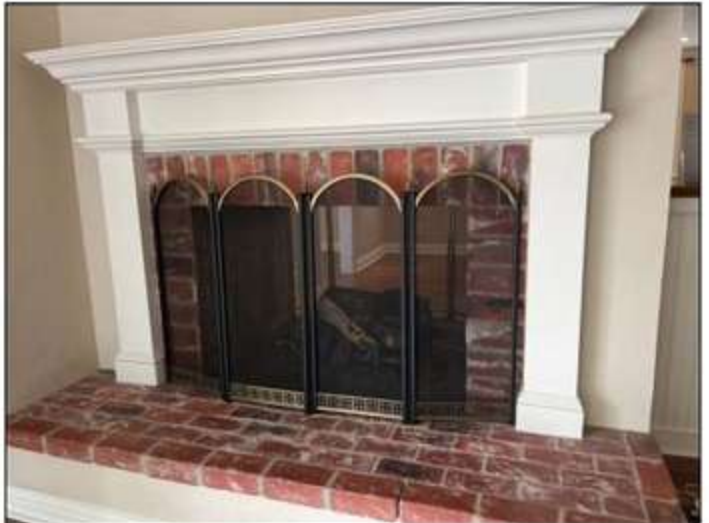
(damper clamp A) Fireplace (A) damper is not blocked opened as required by current safety standards when a gas fired burner assembly is installed (5). Recommend installing a flue damper as an upgrade and may be required by the gas company. Upgrades are recommended as a safety upgrade, subject property was built before current safety standards.

The subject property has a two-way fireplace (5), two-way fireplace are no longer constructed. Double-sided fireplace are no longer constructed in new homes because they are highly prone to improper drafting, which frequently causes smoke to spill directly into the indoor living spaces. Upgrading or modifying the fireplace to meet current architectural and safety standards would entail extensive, costly construction. At a minimum, the fireplace must be evaluated by a licensed chimney contractor to install a proper flue liner and install a damper clamp (2). Recommend further review repair by licensed Chimney contractor.

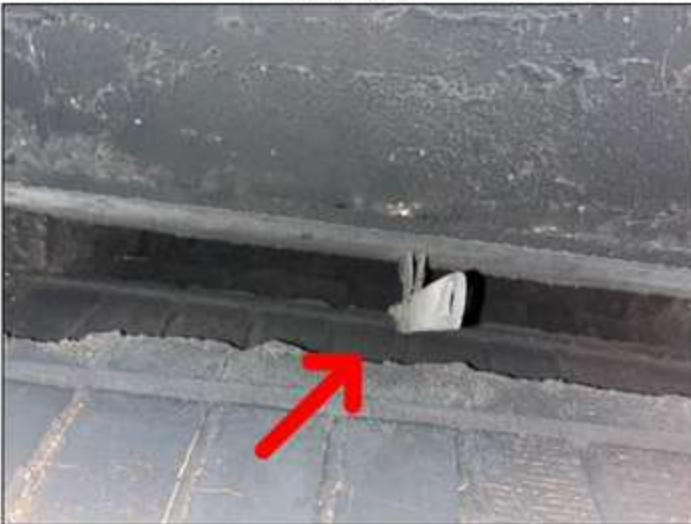
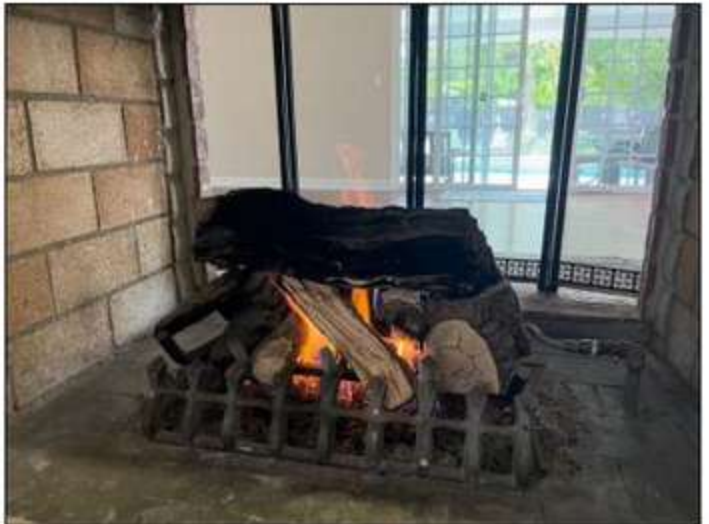
Fireplace (B) Location: Family Room

The subject property has a two-way fireplace (5), two-way fireplace are no longer constructed. Double-sided fireplace are no longer constructed in new homes because they are highly prone to improper drafting, which frequently causes smoke to spill directly into the indoor living spaces. Upgrading or modifying the fireplace to meet current architectural and safety standards would entail extensive, costly construction. At a minimum, the fireplace must be evaluated by a licensed chimney contractor to install a proper flue liner and install a damper clamp (2). Recommend further review repair by licensed Chimney contractor.

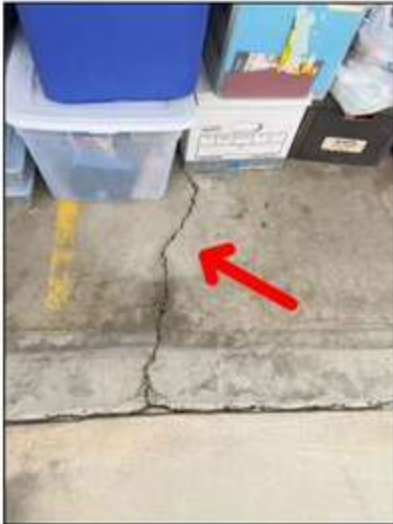
Garage concrete floor had various major cracks, recommend repair (2). Recommend further review and repairs as needed by a qualified licensed contractor or specialty tradesman dealing with this item or system.

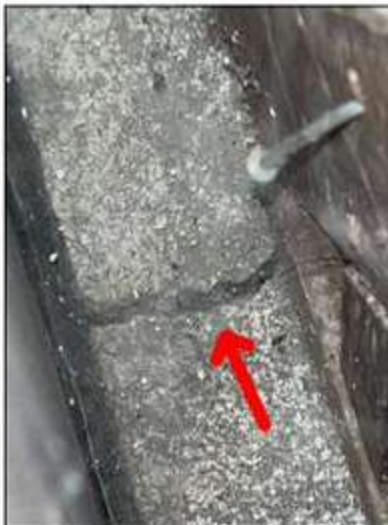
Garage stem wall foundation has visible crack located on West side of garage (2).

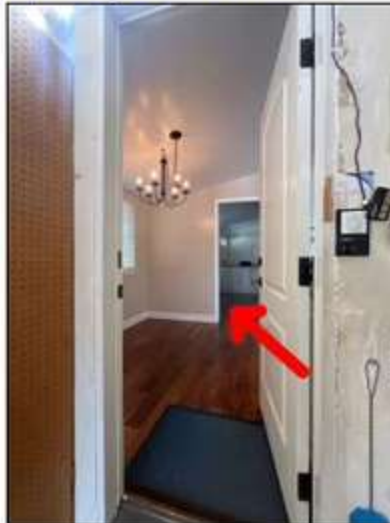
(self close) Garage door to the interior does not have self closing, self latching mechanism installed as required by current standards (5). Recommend installing safety closing mechanism as required by current standards.

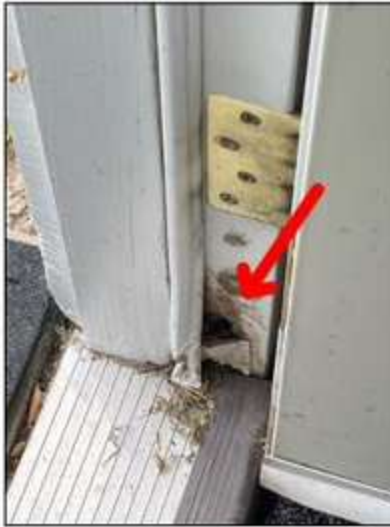
Garage door to the exterior has moisture damage at base of door jam (3), Recommend further review and repair by licensed termite inspector.

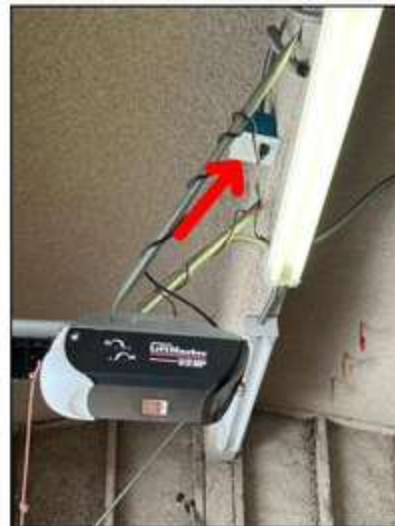
(gfci opener) GFCI electrical outlet not installed at automatic garage door opener electrical receptacle that is controlled by wall switch as required by current standards (5), recommend installing GFCI electrical outlet as an upgrade. (GarageGFCI) Garage electrical outlets do not have GFCI as required by current standards (5). Property was built before current standards, recommend installing as a safety upgrade. GFCI (Ground Fault Circuit Interrupter) outlets are required in garage to enhance electrical safety by reducing the risk of electric shock in wet environments. Even if a property was built before current standards mandated GFCI installation, upgrading to these outlets is crucial for ensuring safety and compliance with modern electrical standards. Retrofitting older properties with GFCI outlets not only protects occupants but also aligns the home with contemporary safety practices.

(no gfci) GFCI electrical outlets are not installed in garage (5). Recommend installing GFCI electrical outlets as required by current standards as a safety upgrade (5). GFCI electrical outlets are required to be installed in garage at any electrical outlet that services garage that is not dedicated to an appliance. Recommend installing as a safety upgrade. GFCI (Ground Fault Circuit Interrupter) outlets are required in garage to enhance electrical safety by reducing the risk of electric shock in wet environments. Even if a property was built before current standards mandated GFCI installation, upgrading to these outlets is crucial for ensuring safety and compliance with modern electrical standards. Retrofitting older properties with GFCI outlets not only protects occupants but also aligns the home with contemporary safety practices.

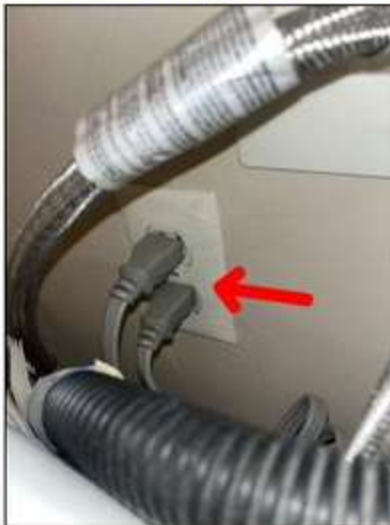
(Not gfc i 5) Electrical outlet for laundry appliances is required to have GFCI protection by current standards (5), recommend installing GFCI electrical outlet to bring up to current standards and is considered an upgrade.

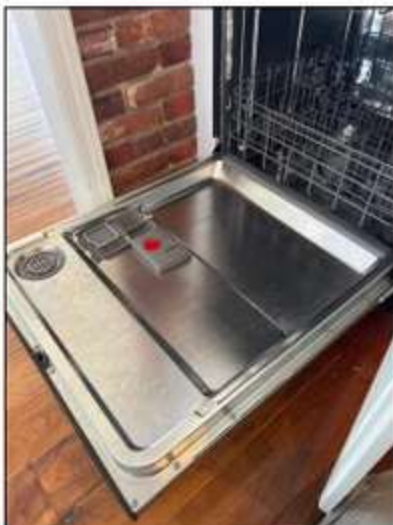
Dishwasher door squeaks when opened \*.

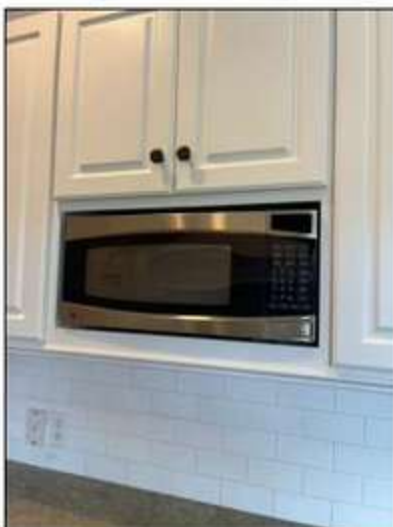
Microwave makes strange noise when operating \*.

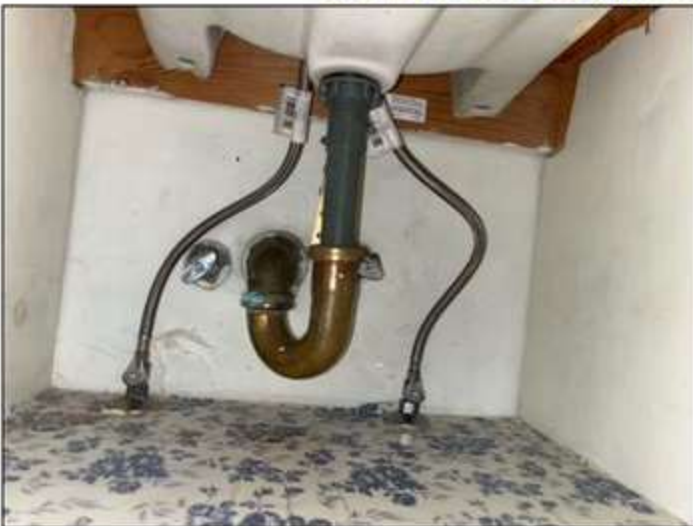
Bathroom (B) sink drain has active leak (2), moisture stain at base of kitchen counter. Recommend further review and repair by licensed plumber.

(flex drain A) Bathroom (A) sink drain has a flex extension form fit drain installed which is not approved in most areas (2), recommend further review and repair by licensed plumber.

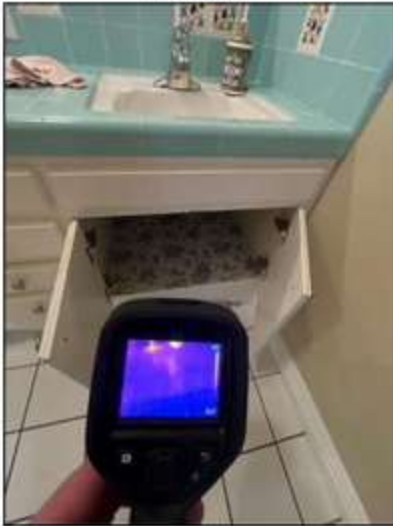
Bathroom (B) sink drain has active leak (2), moisture stain at base of kitchen counter. Recommend further review and repair by licensed plumber. The thermal imaging camera was used to inspect area which detected active leak.

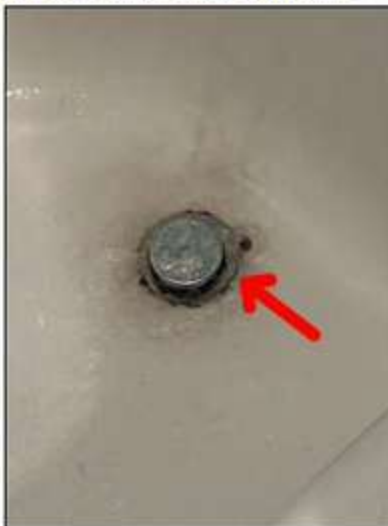
Bathroom (B) bathtub has rust stains at drain \*.

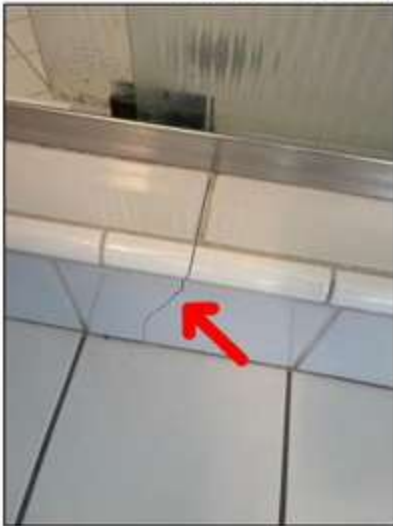
Bathroom (A) tile shower enclosure curb has visible crack at both sides of curb (2), the crack may allow shower pan to leak. Recommend further review repair by licensed contractor.
